CHARACTERIZATION AND ASSESSMENT OF THE CRANBURY BROOK WATERSHED

Steve Yergeau, Watershed Assessment Specialist
Priya Sankalia, GIS Specialist

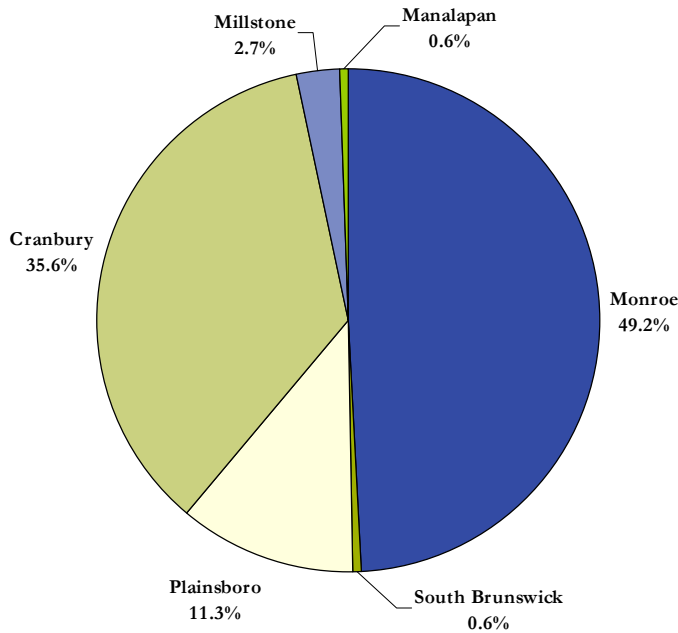
Graph 1: Percentage of the Cranbury Brook Watershed area within each municipality.

Municipality	County	Acres in the Cranbury Brook Watershed
Monroe Township	Middlesex	7,003
Cranbury Township	Middlesex	5,071
Plainsboro Township	Middlesex	1,608
Millstone Township	Monmouth	385
Manalapan Township	Middlesex	92
South Brunswick Township	Middlesex	81
TOTAL	---	14,240

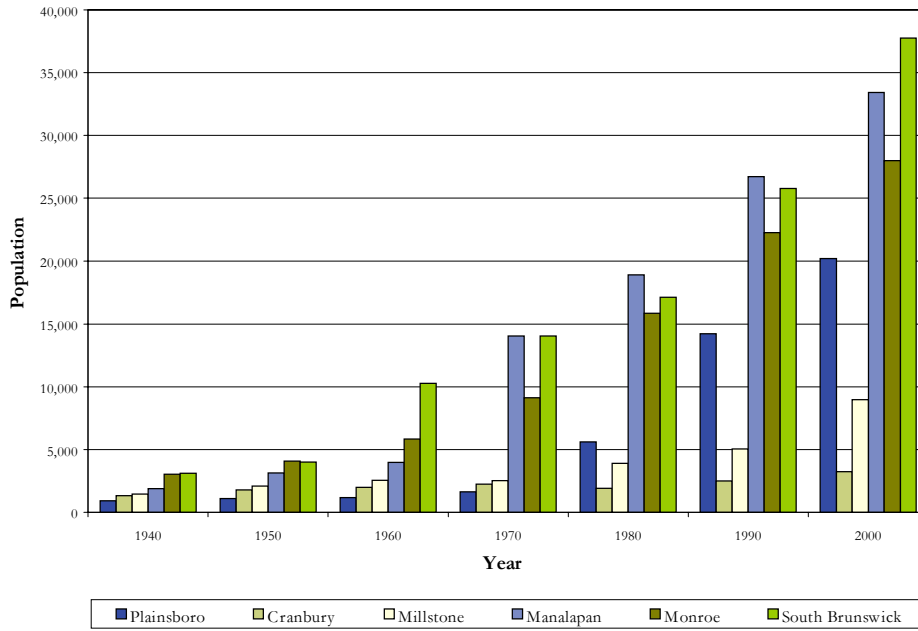
Graph 2: Historical population of the Cranbury Brook Watershed, by municipality. *

The total population for the towns located within Cranbury Brook Watershed has increased more than ten-fold in 60 years, from 11,796 people in 1940 to 131,568 in 2000 (Graph 2 and Table 2). Total population increased at an average rate of 1,996 people per year. In comparison, the rate of increase between 1970 and 2000 was 2,930 people per year. Between 1940 and 2000, population changes for people living within the six municipalities found partially or fully within the Watershed show that growth occurred in each of the municipalities (Table 2 and Graph 2).

The largest population increase occurred in Plainsboro Township. Plainsboro experienced a 2,085% increase in residents between 1940 and 2000, as it went from 925 residents in 1940 to a population of 20,215 in 2000 (Table 2 and Graph 2). Plainsboro contributed a large percent of the 2000 population (15.4%) for the municipalities found all or part in the Cranbury Brook Watershed, while contributing to 11.3% of the entire watershed area (Graph 3 and Table 2). With such an increasing population in one municipality that constitutes a major portion of the Cranbury Brook Watershed, local governance needs to thoughtfully plan out the future direction of development within Plainsboro.

The smallest change in population was found in Cranbury Township with only a 140% increase in population over 60 years (Table 2 and Graph 2). In fact, over the last 30 years, Cranbury only gained 974 residents while the other municipalities gained between 6,435 and 23,676 residents in that same time period (Table 3). With the slow population growth rate and a small gain of residents over the past 30 years, Cranbury maintains the lowest density of residents in the Cranbury Brook Watershed with an average of 241 residents per square mile (New Jersey State Data Center 2001; Figure 3). Much of the density is distributed near major roadways like State Route 130 and the New Jersey Turnpike, where many businesses and direct connections to these roadways are located (Figure 3 and Figure 4).

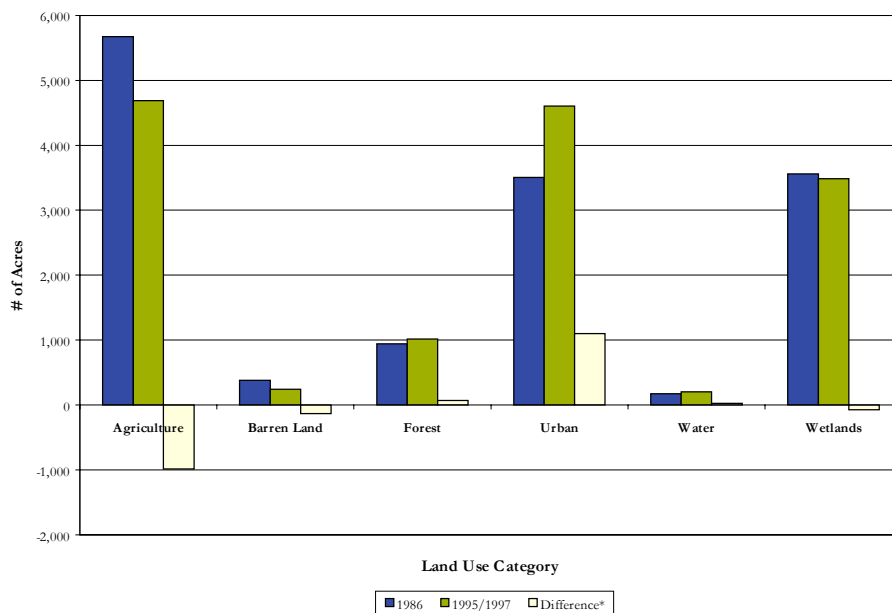
Graph 4: Changes in acreage of land uses in the Cranbury Brook Watershed from 1986 to 1995/97.

1986 and 1995/97, the landscape draining to Cranbury Brook has changed due to shifts in land use as well as increases in population and local preservation efforts (Figure 13). To accommodate the increasing population, the agricultural lands are being developed to provide housing and services for new residents, including commercial and industrial areas. The changes in land use were a loss of 986.0 acres, or 17.0%, of agricultural lands, and an increase of 1,098.0 acres, or 31.0%, in urban areas (Graph 4).

Since 1986, there has been a slight gain in forested lands in the Cranbury Brook Watershed (Graph 5). In 1986, 6.6% of the Watershed, or 944.7 acres, was forested (Graph 4 and Graph 5). In 1995/97, 7.1% of the Watershed, or 1,015.2 acres, was covered with forests (Graph 4 and Graph 5). The woodlands are found scattered in small patches throughout the Cranbury Brook Watershed (Figure 12).

In both 1986 and 1995/97, the largest land use category within the Cranbury Brook Watershed was agriculture (Graph 4 and Graph 5). Up until the 1960s, there were many potato and dairy farms throughout Middlesex County. Today, Middlesex County has over 120 part and full time farmers, with most of the farmland concentrated in Cranbury, Monroe and Plainsboro Townships (Hlubik 2002; Figure 12). Farms currently specialize in intensive agriculture such as fruit and vegetable production. Almost all of the agriculture is located near the streams and wetlands found in the Watershed, especially surrounding the tributaries that lead to the Cranbury Brook (Figure 12). In the past, these streams were used to irrigate the crops or water the livestock on many of the region's farms.

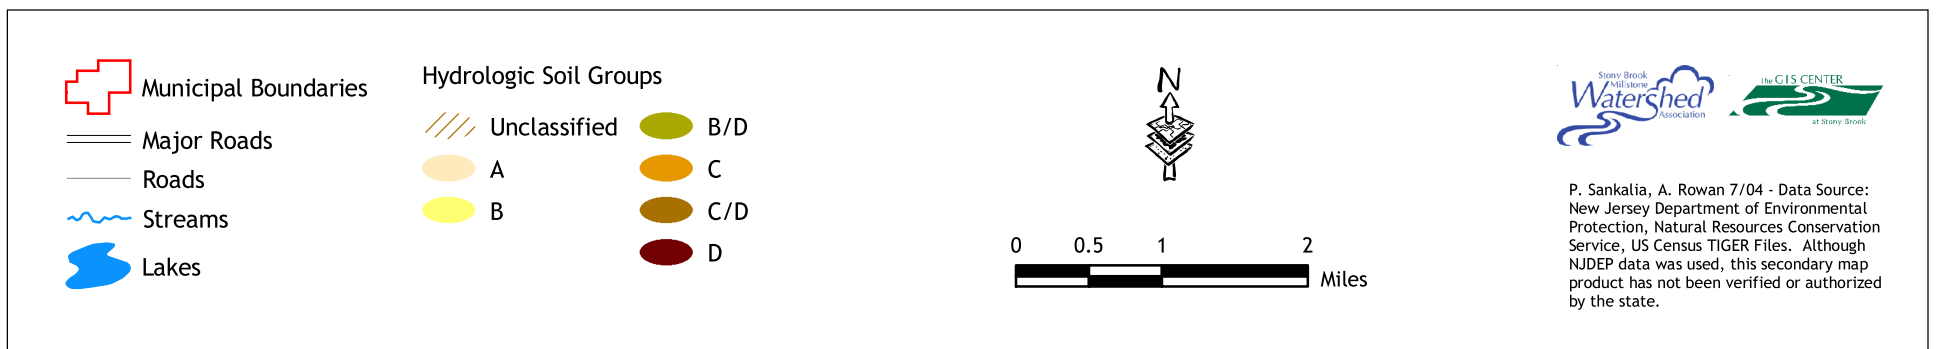
Figure 10: Hydrologic Soil Groups in Cranbury Brook Watershed

Based upon their various compositions, soil series infiltrate water to varying degrees. Their ability to drain water, especially from precipitation, is evaluated and reported as the hydrologic soil group. Much of the Cranbury Brook is classified as hydrologic soil group B, covering 6,616.4 acres out of a total of 14,240.4 acres (46.5%) in the entire Watershed (Figure 10). Hydrologic soil group B represents soils with a moderate infiltration rate and is representative of the moderately coarse soils seen in the Coastal Plain Physiographic Province. Most of this hydrologic soil group underlies the agricultural areas in Monroe and Cranbury Townships and the developed areas in Plainsboro (Figure 10). The second most common hydrologic soil group in the Cranbury Brook Watershed is group C, representing slow infiltration rates and the fine to moderately fine soils in the area (Figure 10).

The hydrologic soils in group D are found primarily as streambeds in the Cranbury Brook Watershed (Figure 10). Category D soil groups have very slow infiltration rates since most of these soils are clayey or have an impervious layer near the surface (Figure 10).
