# 1<sup>ST</sup> CONSTITUTION BANK 140 MERCER STREET

**1ST CONSTITUTION BANK  
140 MERCER STREET**

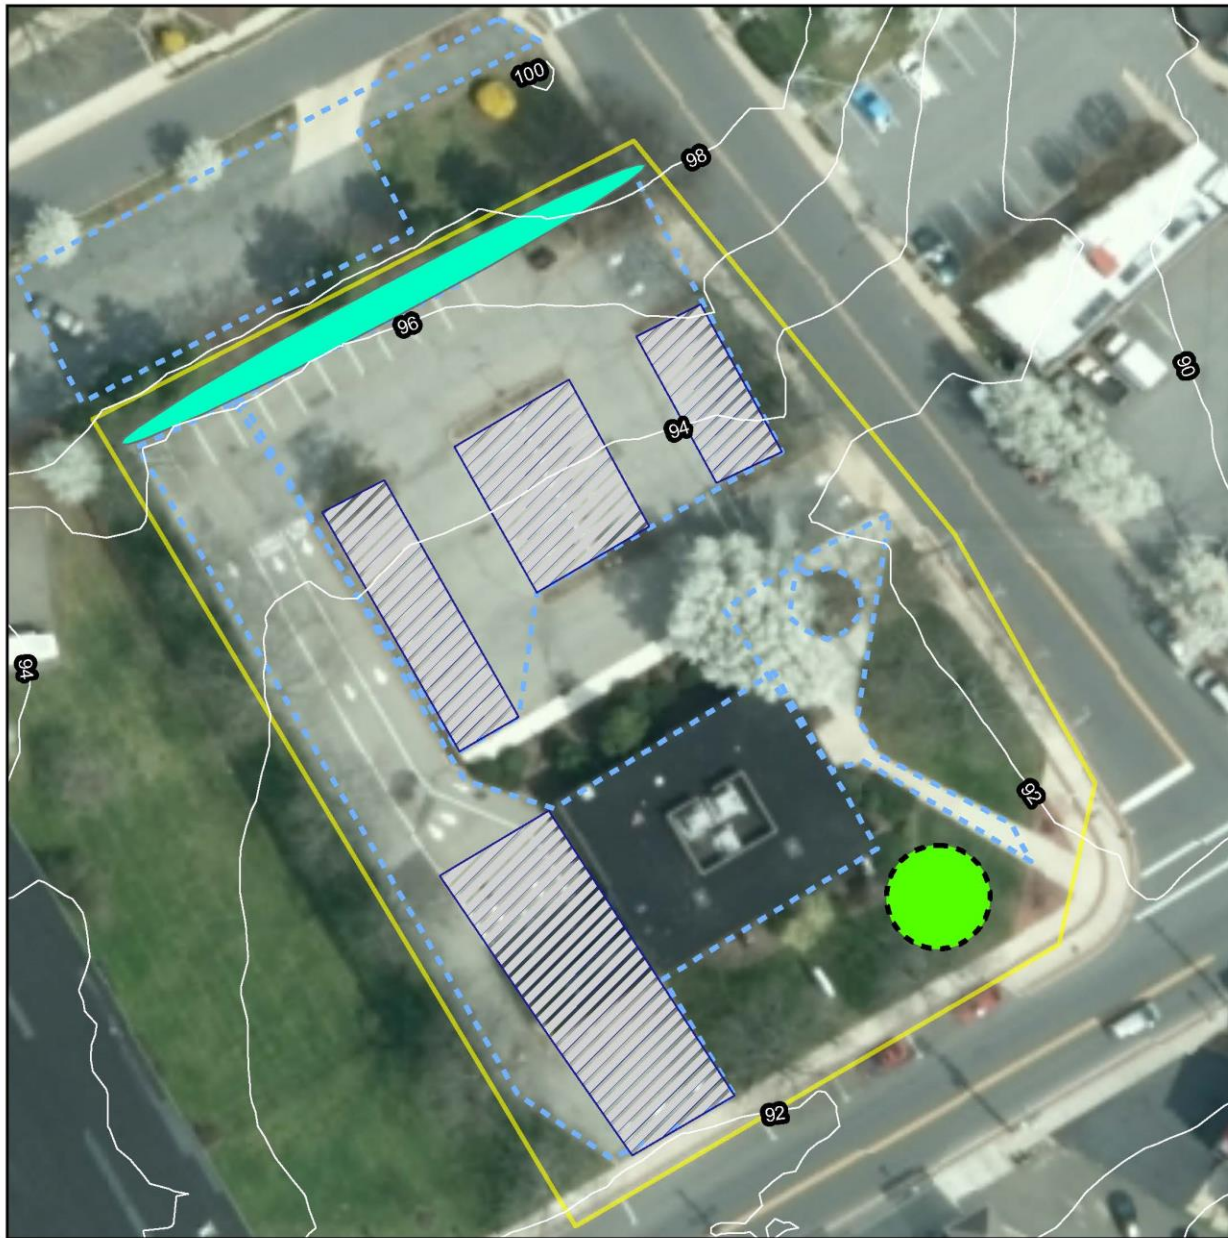
A bioswale in the rear of the parking lot will stop runoff from the neighboring parking area and strategically placed pervious pavement will capture runoff from parking and roof surfaces. A rain garden in the front will treat runoff from the sidewalk.

-   Property Line
-   Drainage Area
-   Bioswale
-   Porous Pavement
-   Rain Garden

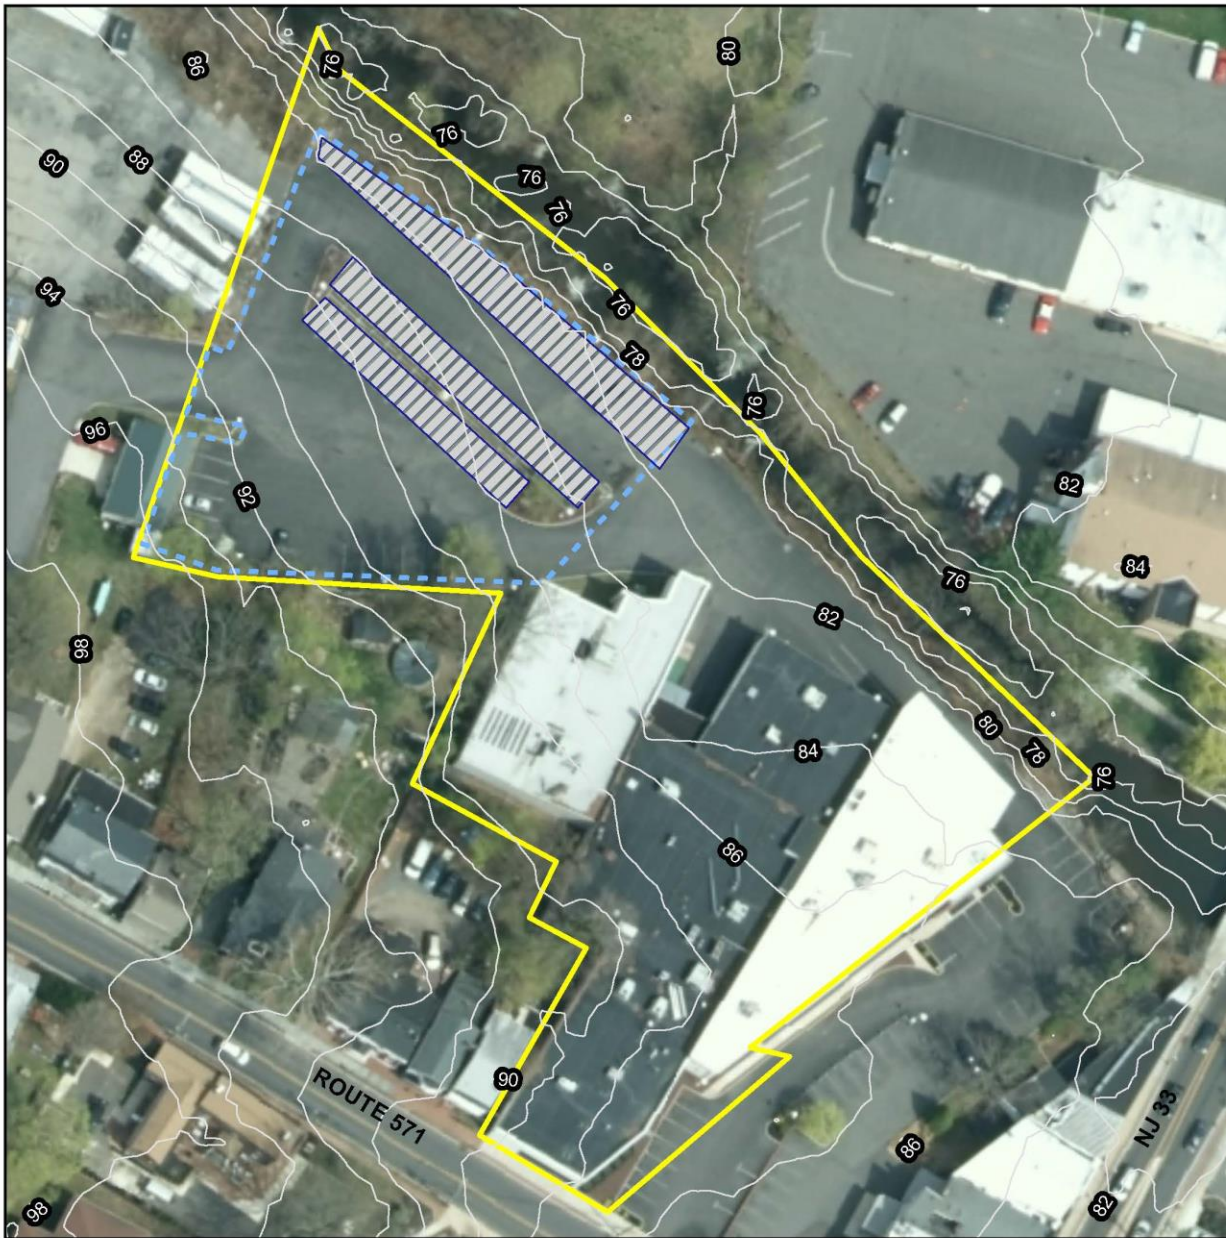
**CCL LABEL  
118 STOCKTON STREET**

Installing porous pavement in parking spaces in the rear lot will remediate 38.9% of the site's impervious cover and could remove 20.1 pounds of pollutants from the Rocky Brook annually and restore 883,000 gallons of water to the natural water cycle.

-   Property Line
-   Drainage Area
-   Porous Pavement

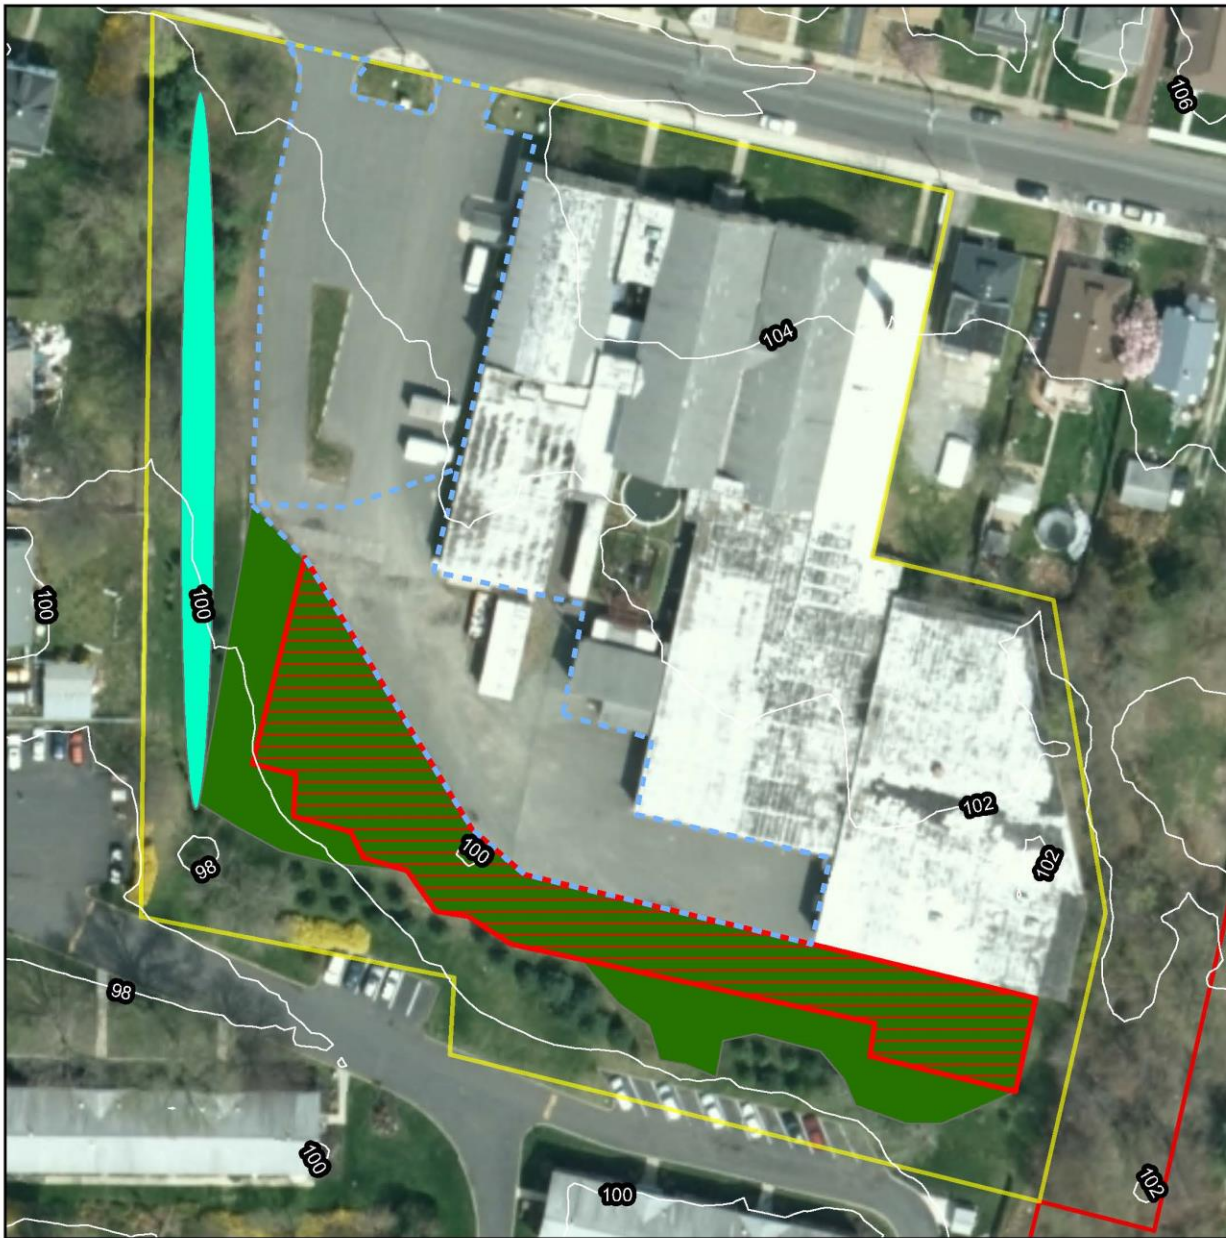
**EMPIRE ANTIQUES  
278 MONMOUTH STREET**

Depaving the unused portion of pavement and gravel and replacing it with a vegetated filter will treat the runoff from the delivery area, while a bioswale along the side of the property will capture runoff from the driveway and parking lot.

-   Property Line
-   Drainage Area
-   Bioswale
-   Depave
-   Vegetated Filter

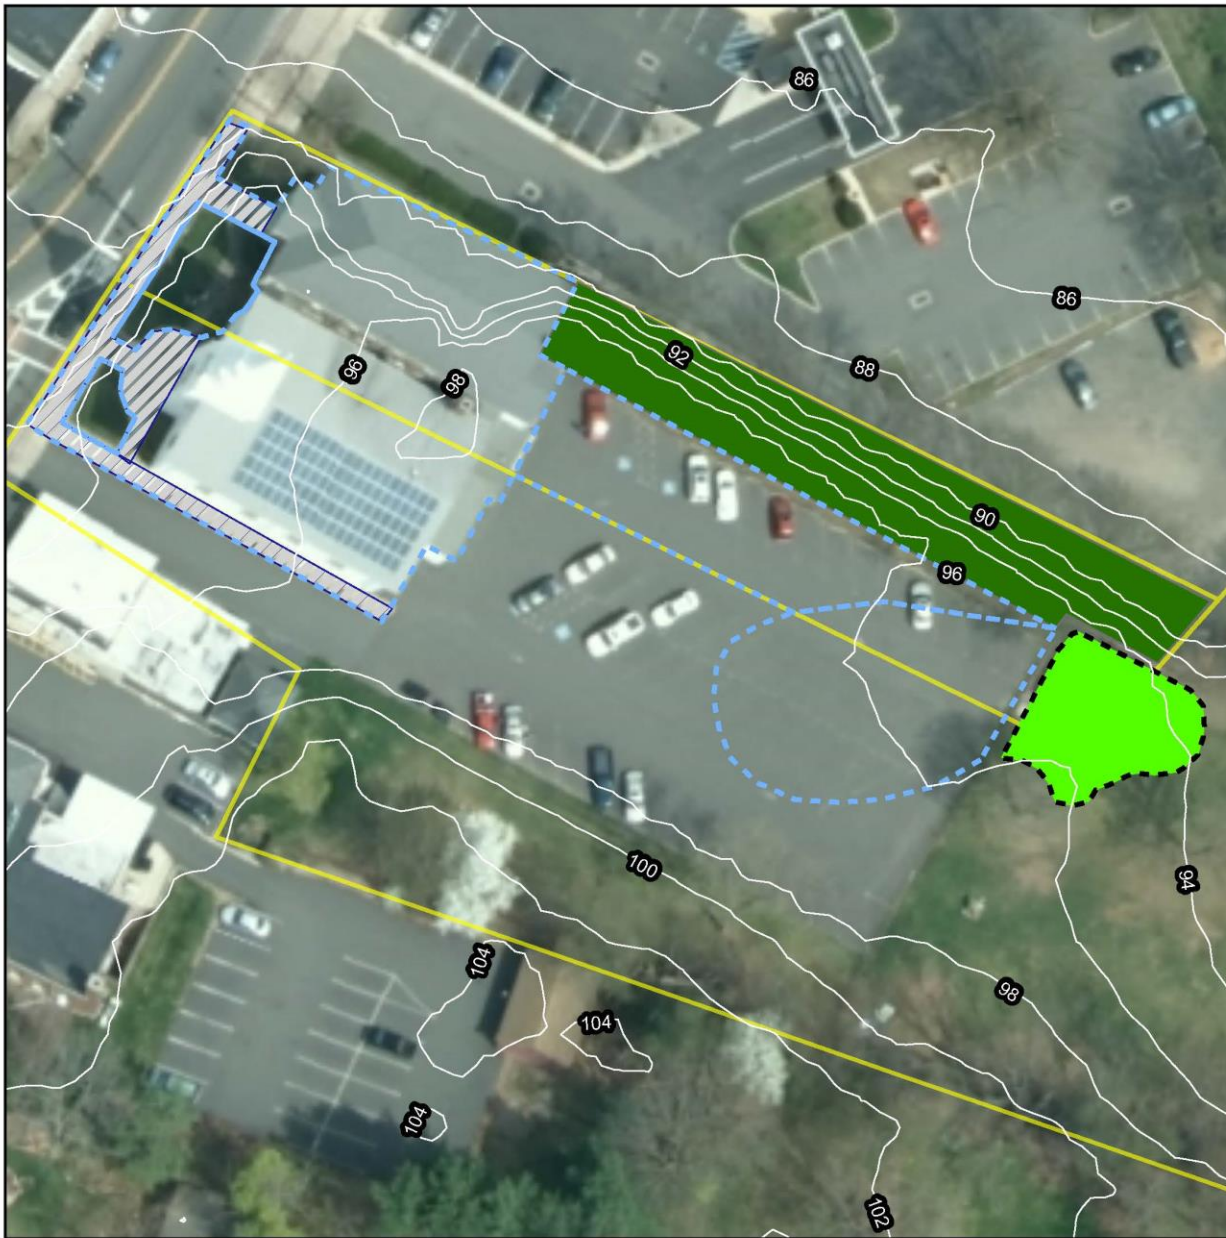
**FIRST BAPTIST CHURCH  
125 S MAIN STREET**

Replacing the sidewalks with porous pavement would capture and treat runoff from the roof. Together, a rain garden and vegetated filter would help treat much of the runoff from the parking lot.

-   Property Line
-   Drainage Area
-   Porous Pavement
-   Rain Garden
-   Vegetated Filter

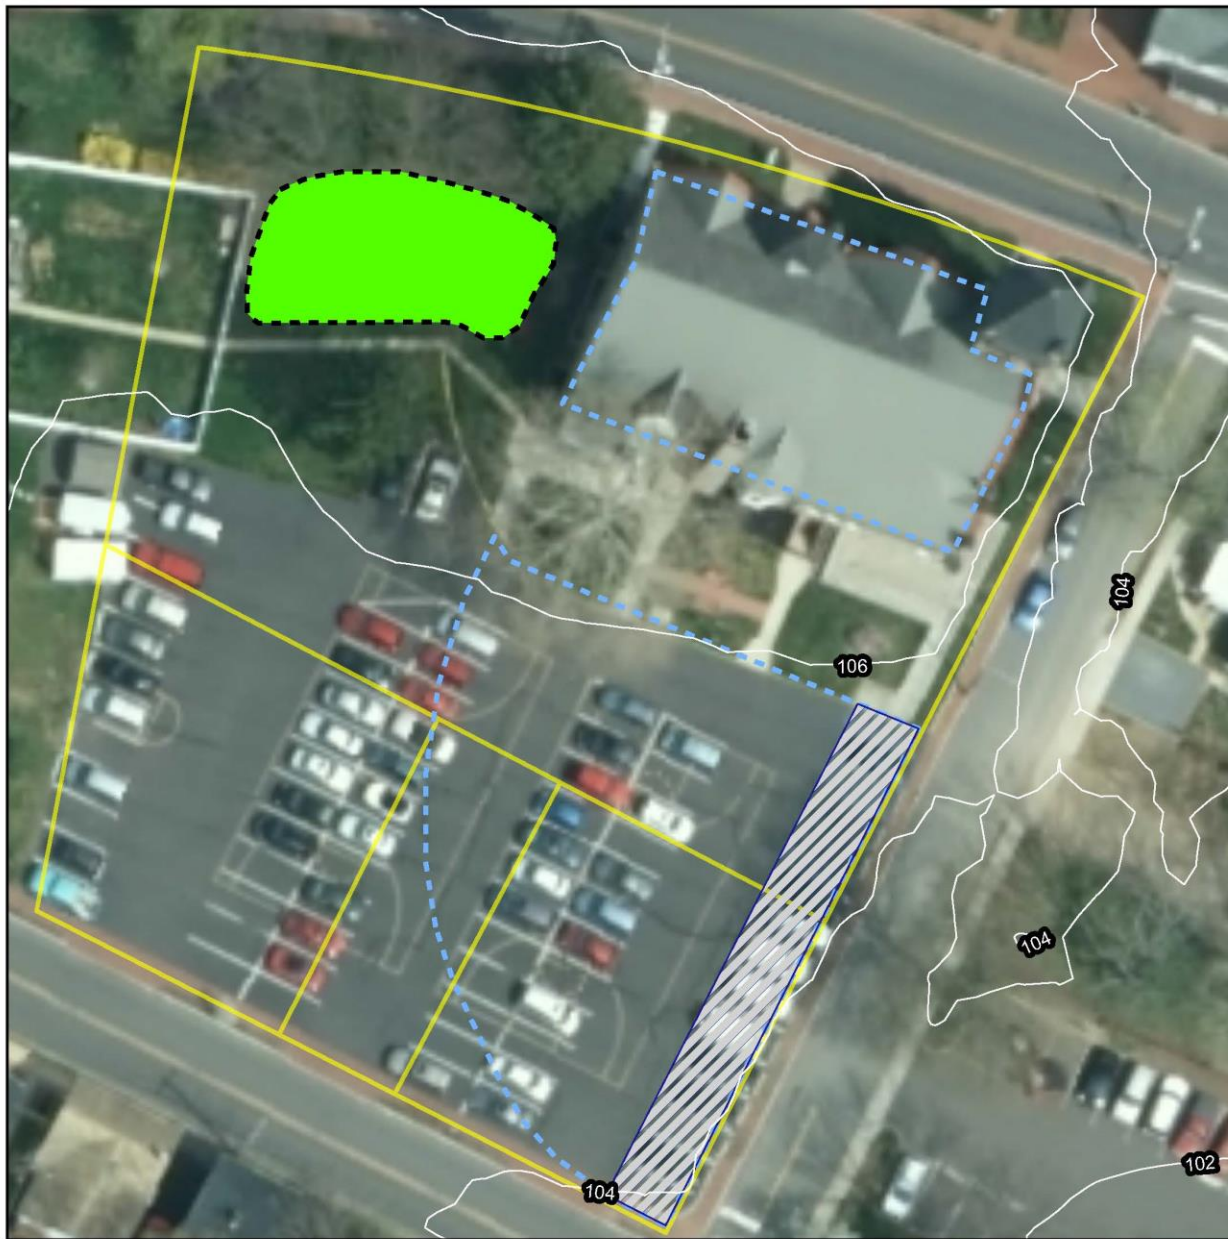
**FIRST UNITED METHODIST CHURCH  
187 STOCKTON STREET**

A rain garden along the sidewalk could treat all of the runoff from the roof, while porous pavement in the parking spaces on the far side of the parking lot would treat much of the parking lot.

-   Property Line
-   Drainage Area
-   Porous Pavement
-   Rain Garden

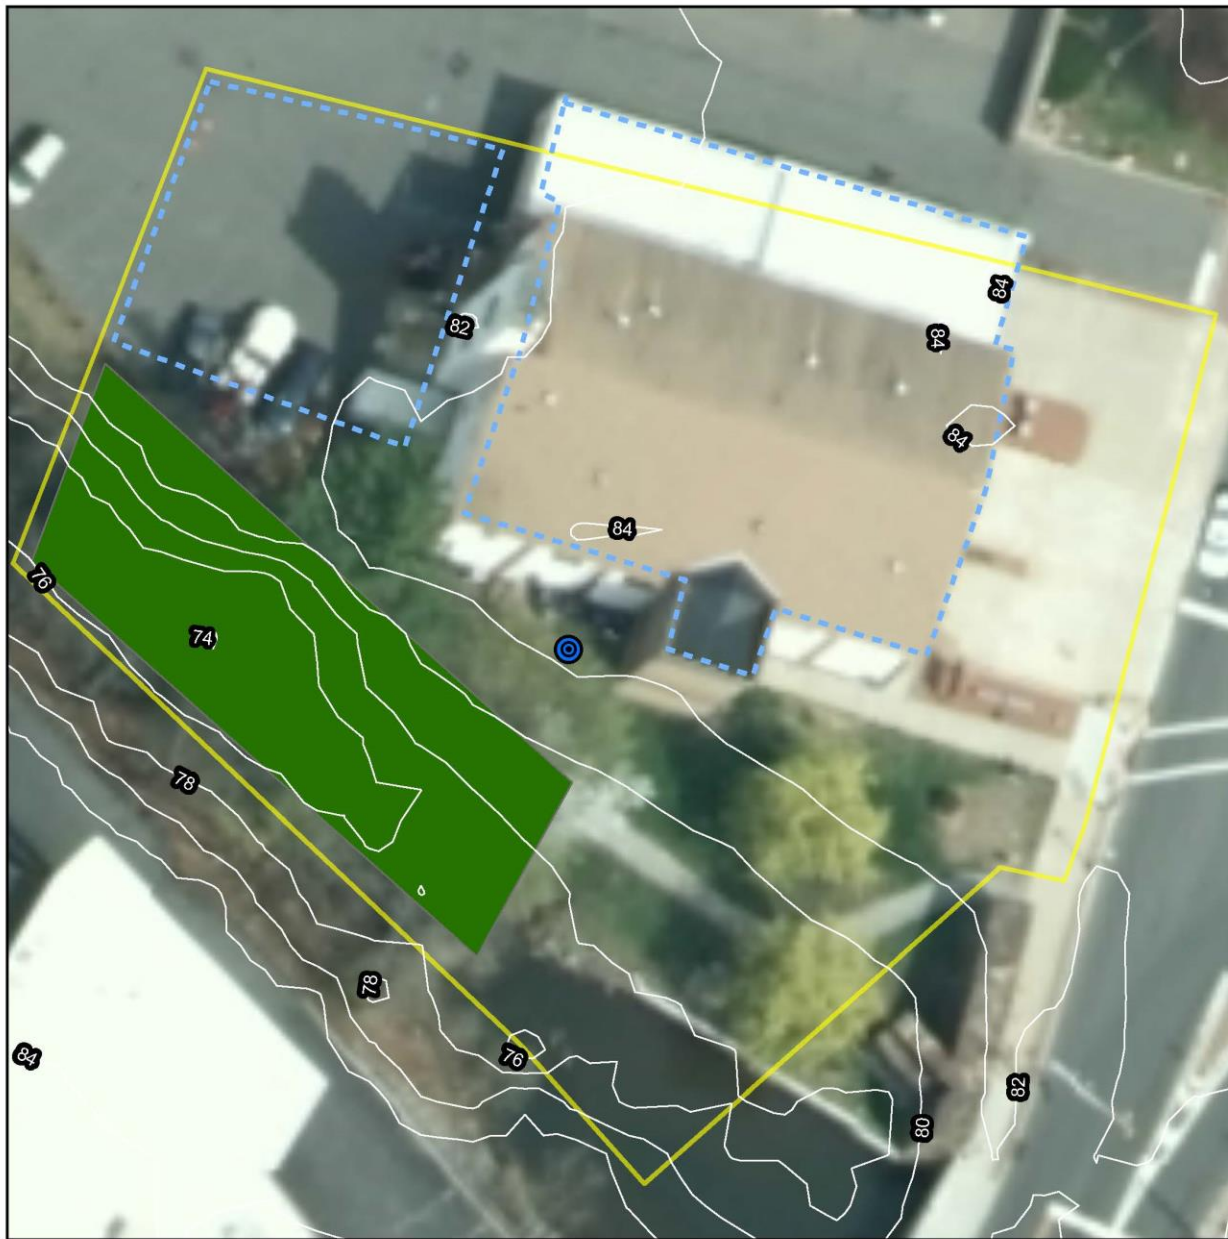
## HIGHTSTOWN FIRE DEPARTMENT 140 N MAIN STREET

A 2,200 gallon cistern would capture and store runoff from the roof for the Fire Dept's later use, and a vegetated filter would help remove pollutants from the parking lot runoff before it reaches the stream.

-   Property Line
-   Drainage Area
-   Cistern
-   Vegetated Filter

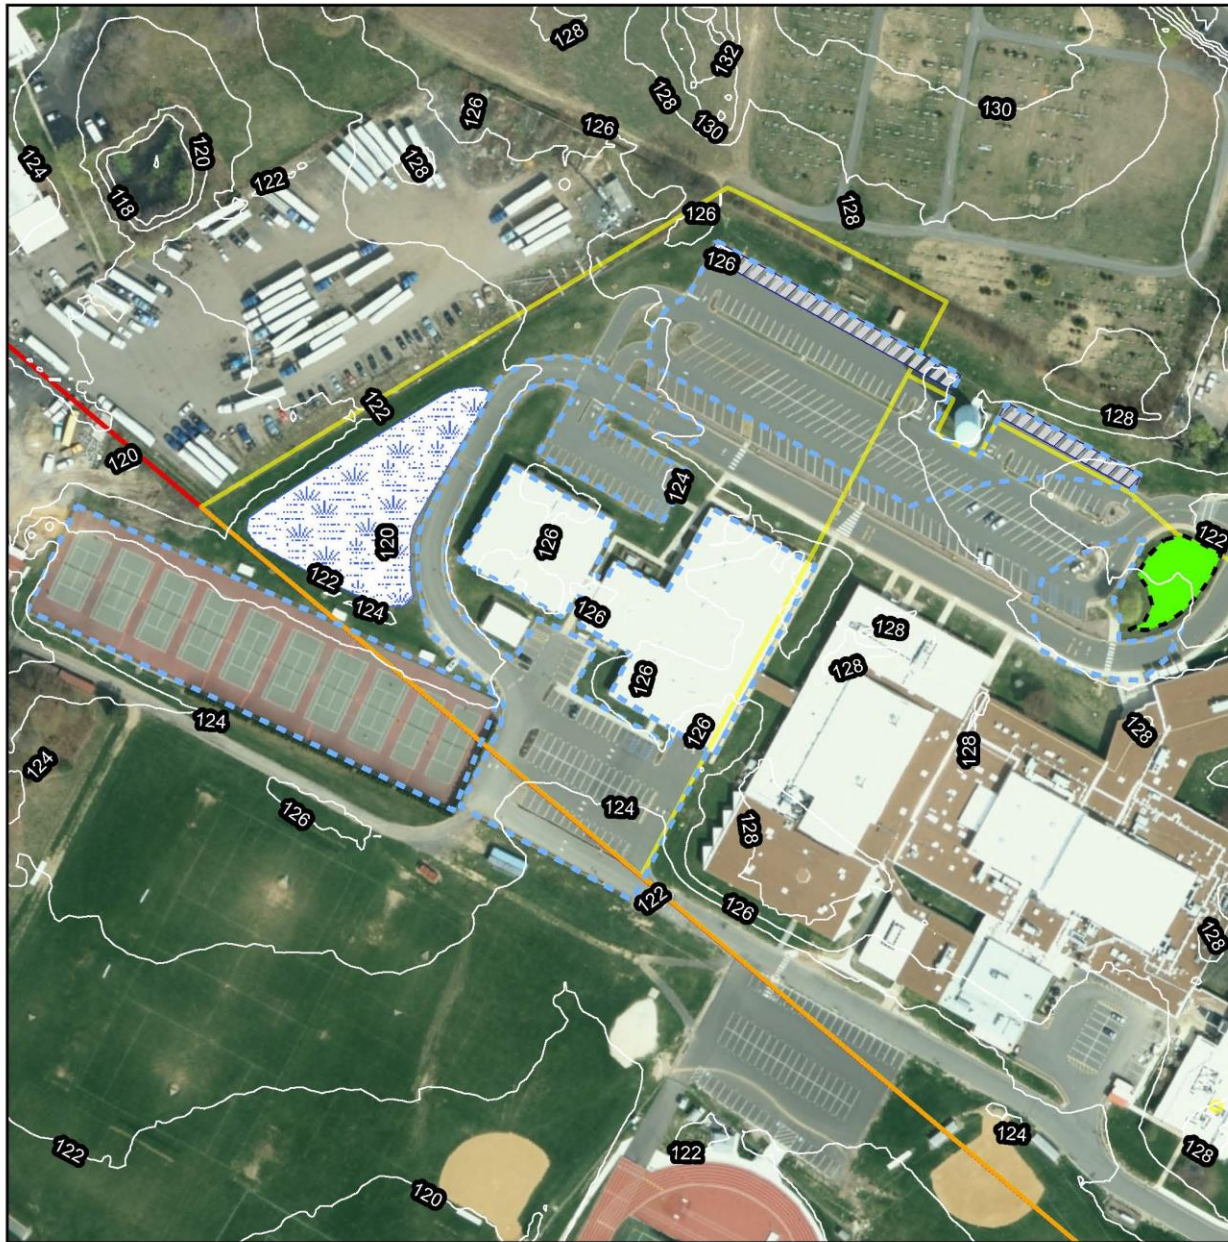
## HIGHTSTOWN HIGH SCHOOL 25 LESHIN LANE

Naturalizing the existing stormwater basin will treat a large percentage of the runoff from the driveways, roof and nearby parking lots, as well as the tennis courts. Porous pavement, along with a rain garden installed in the median, will capture and treat runoff from the rear lot.

Stormwater Basin  
Naturalization

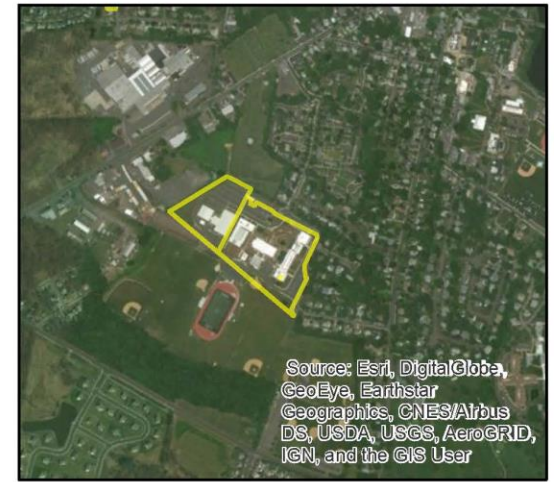
Property Line
-

Drainage Area
-

Porous Pavement
-

Rain Garden
-

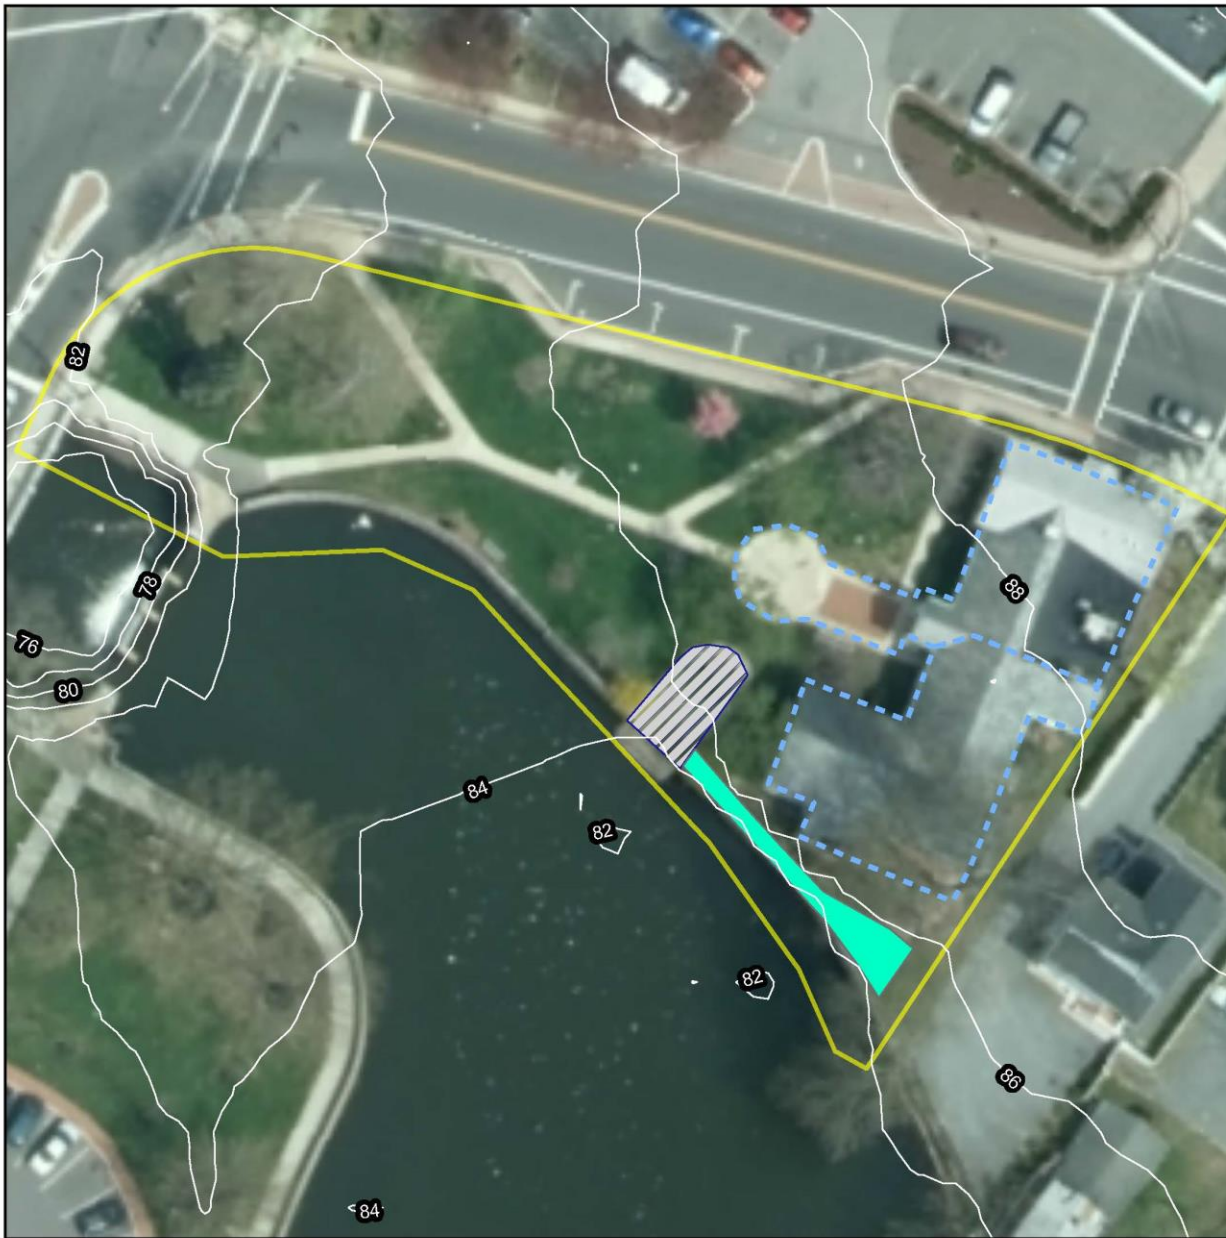
**HIGHTSTOWN LIBRARY  
MEMORIAL BRANCH  
114 FRANKLIN STREET**

Repaving the concrete lookout area and installing a bioswale along the bank, will capture and treat runoff from the roof of the library before pollutants reach the lake.

-   Property Line
-   Drainage Area
-   Bioswale
-   Porous Pavement

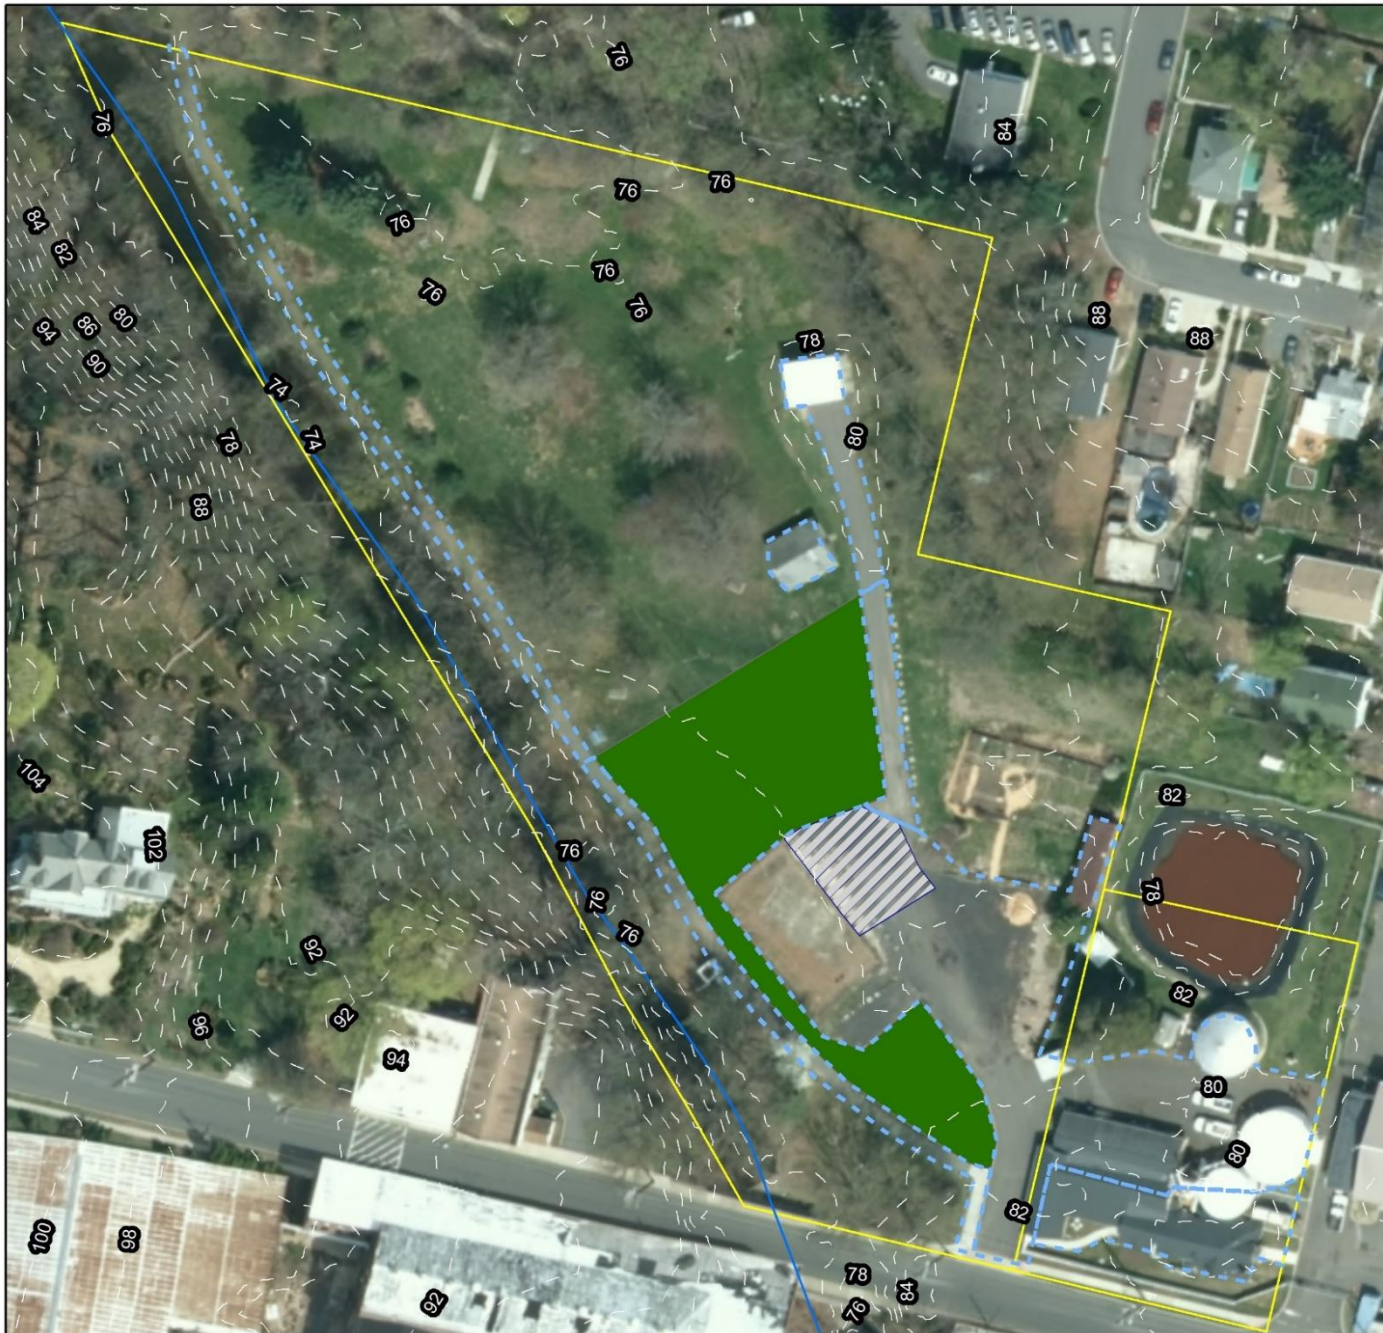
## Rocky Brook Park

Removing existing impervious surfaces and installing a vegetative filter and pervious pavement would remediate 76.6% of the site's impervious cover and could remove 41.5 pounds of pollutants from Rocky Brook annually and restore 981 thousand gallons of water to the natural water cycle.

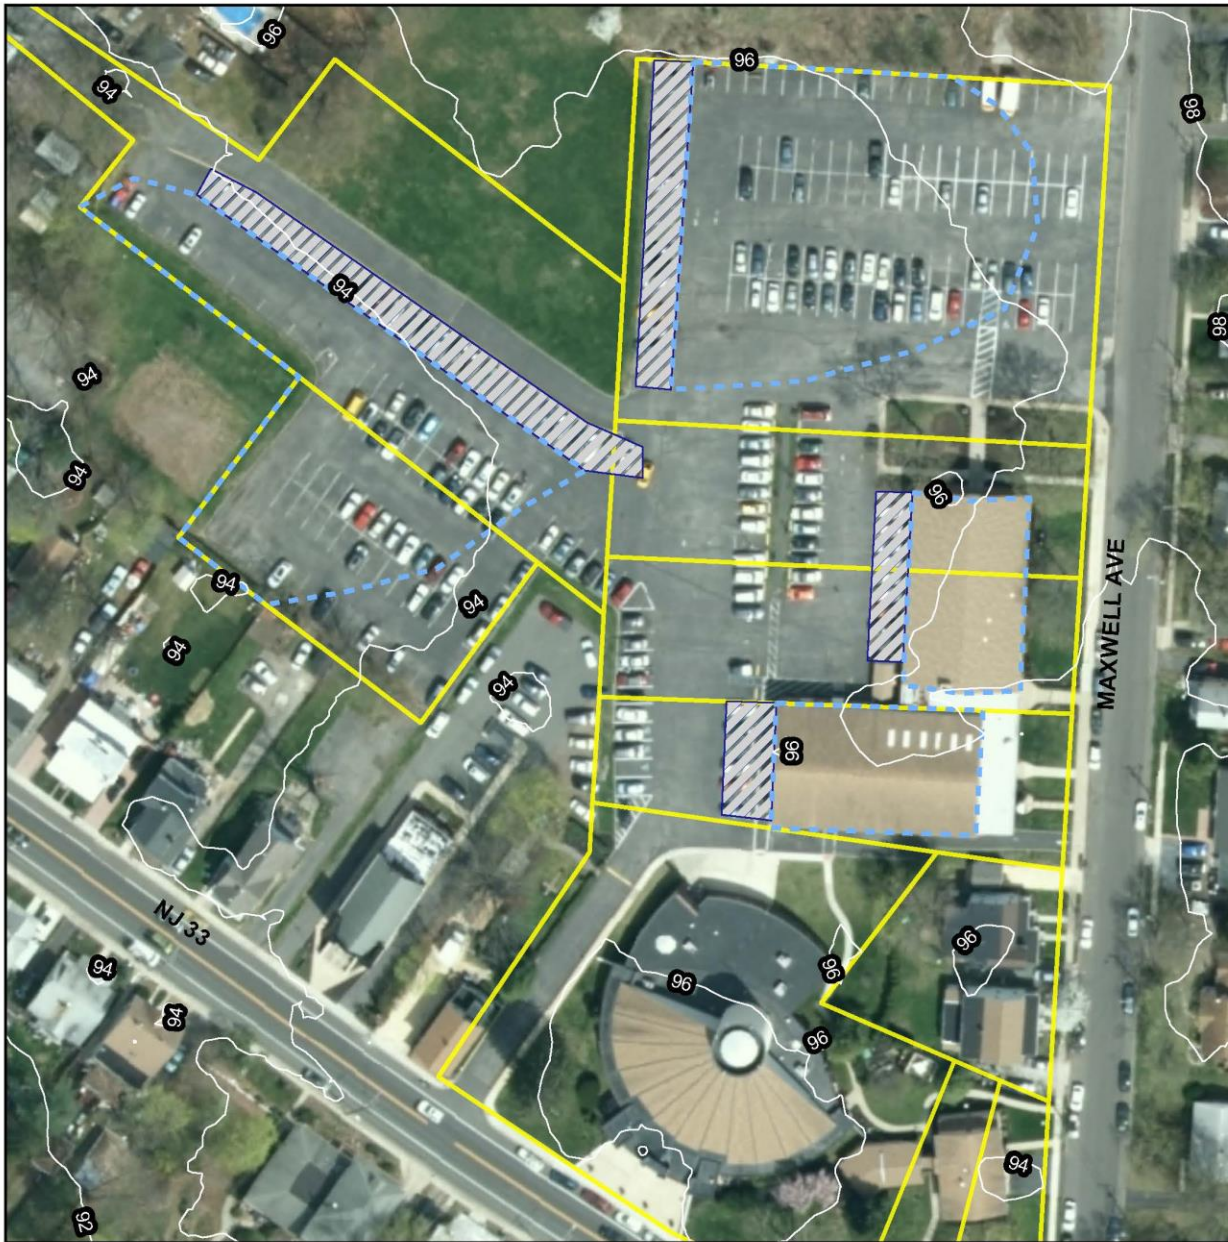
**SAINT ANTHONY  
OF PADUA CHURCH  
251 FRANKLIN STREET**

Replacing parking spaces in strategic areas with porous pavement will remediate 46.1% of the site's impervious cover and could remove 32.7 pounds of pollutants from the Rocky Brook annually and restore 2.34 million gallons of water to the natural water cycle.

-   Property Line
-   Drainage Area
-   Porous Pavement

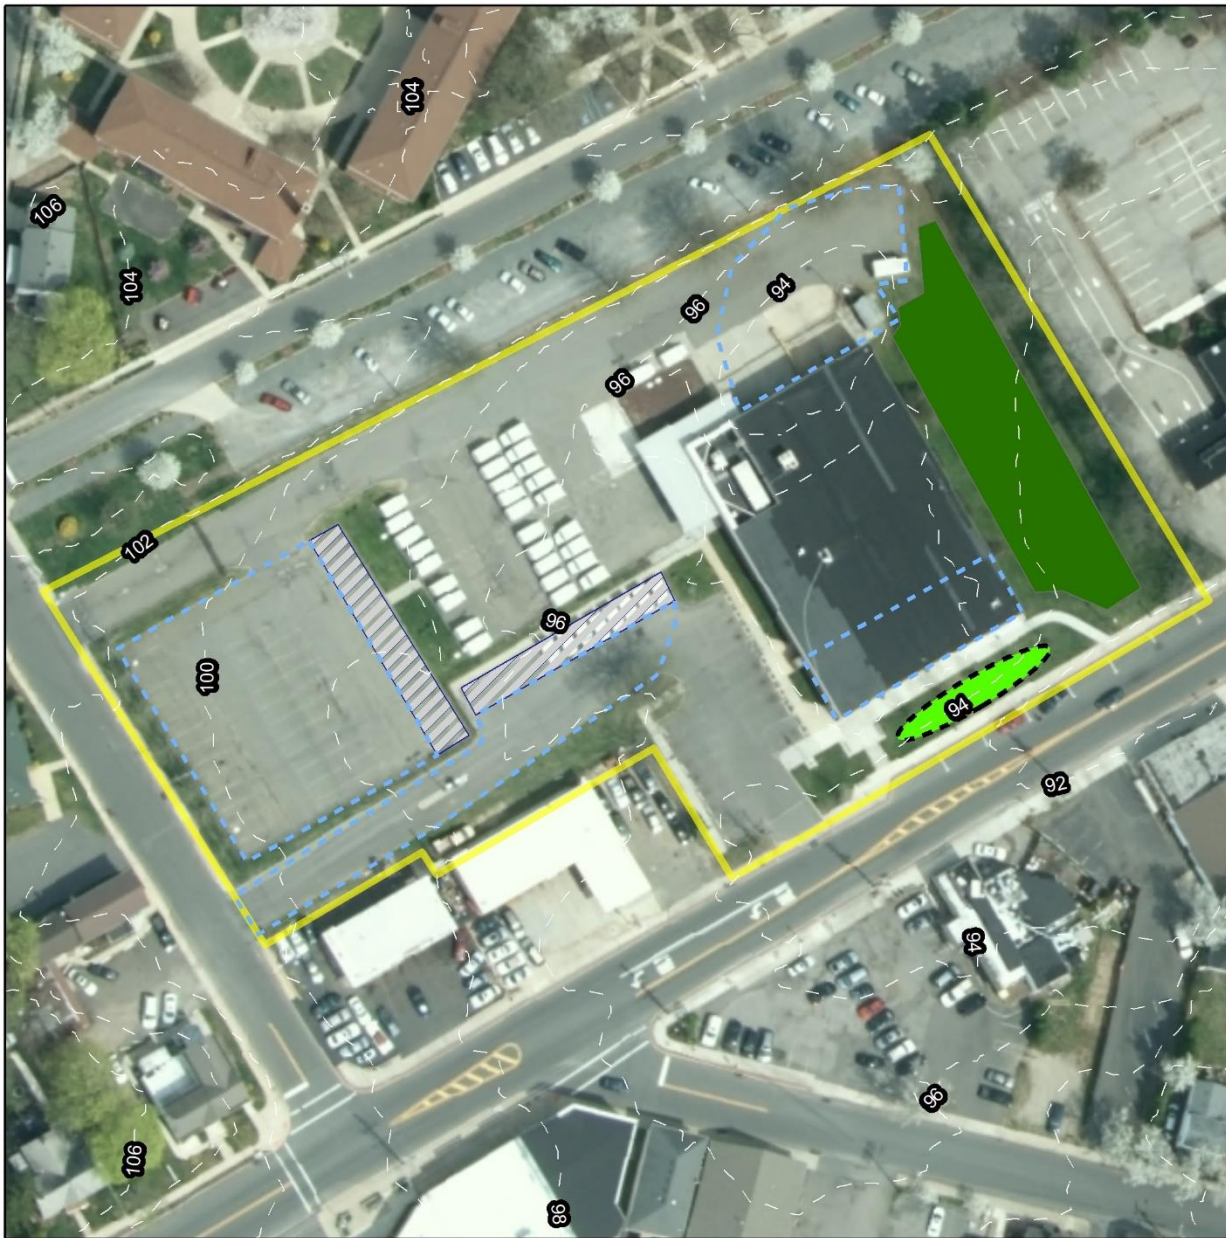
**UNITED STATES POST OFFICE  
150 MERCER STREET**

A vegetated filter along the side of the building will beautify a currently unused space and capture runoff from the loading area. A rain garden in the front of the building will help treat some of the roof runoff, and porous pavement in some of the parking spots will remediate much of the driveway.

-   Property Line
-   Drainage Area
-   Porous Pavement
-   Rain Garden
-   Vegetated Filter

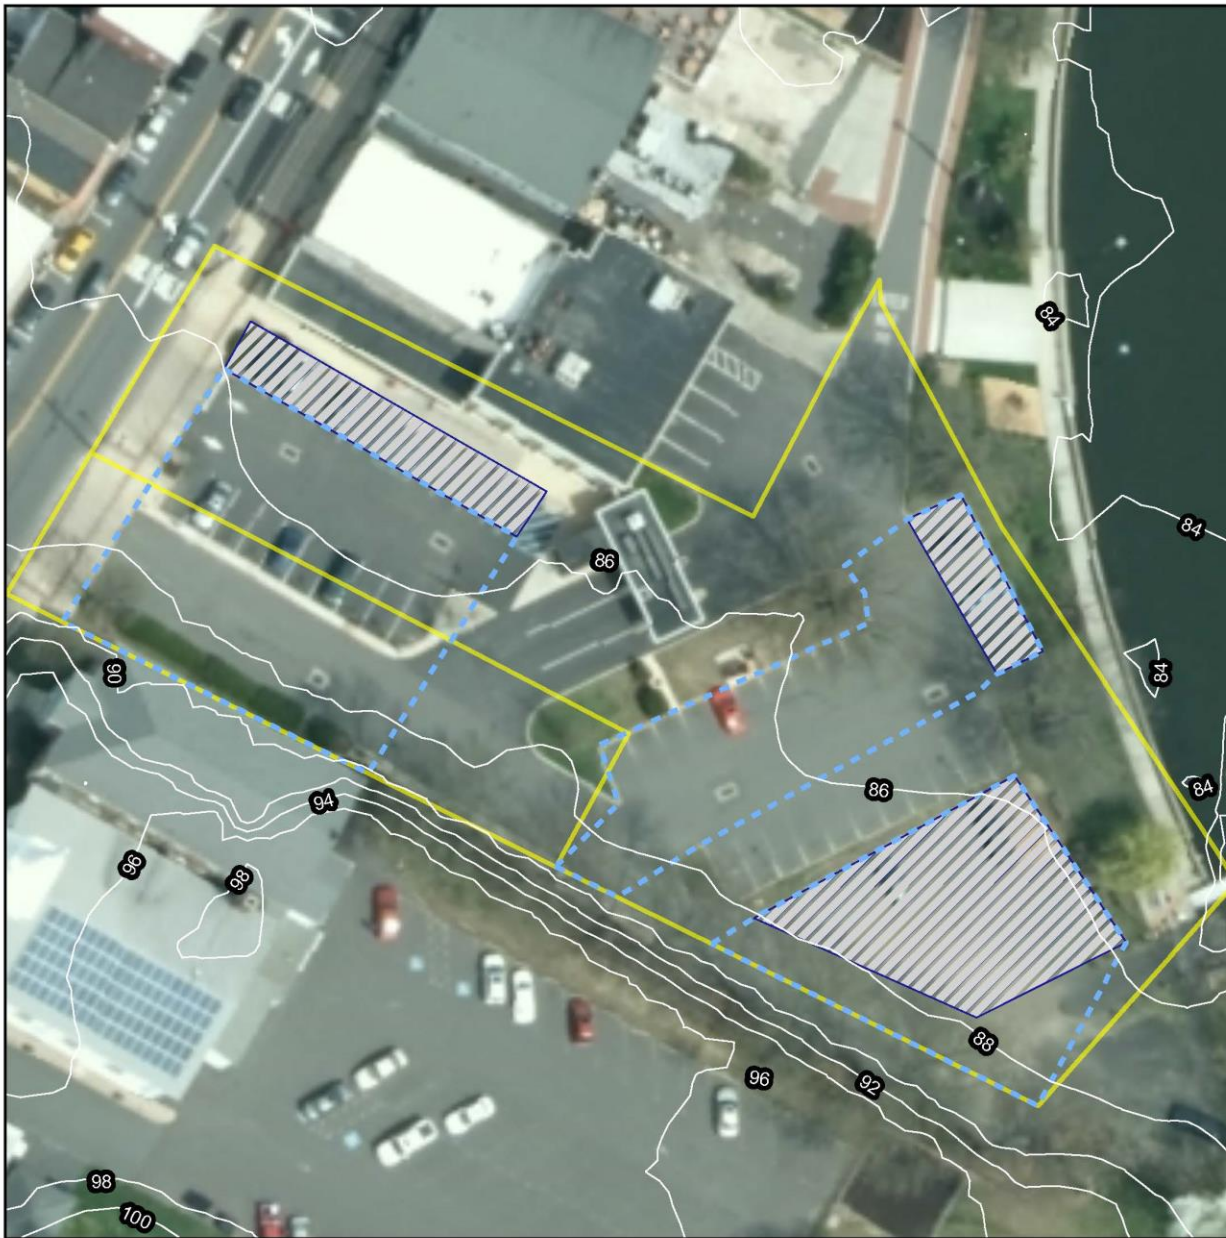
## WELLS FARGO 105 MAIN STREET

Replacing the compacted gravel lot with pervious pavement, as well as installing gravel porous pavement in strategically placed parking spaces will remediate 50.2% of the site's impervious cover and could remove 16.4 pounds of pollutants from the Rocky Brook annually and restore 608,000 gallons of water to the natural water cycle.

-   Property Line
-   Drainage Area
-   Porous Pavement
