1ST CONSTITUTION BANK 86 EAST BROAD STREET

This site currently has 24,700 square feet of impervious cover, creating 723,000 gallons of stormwater runoff and flushing 127 pounds of pollutants into Beden's Brook each year.

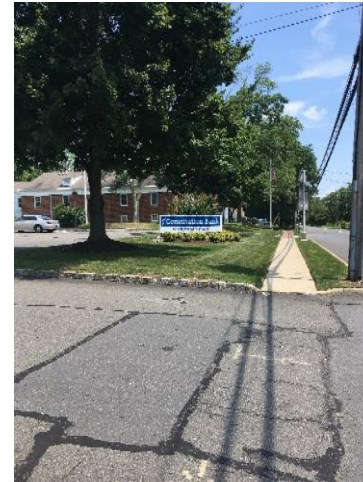
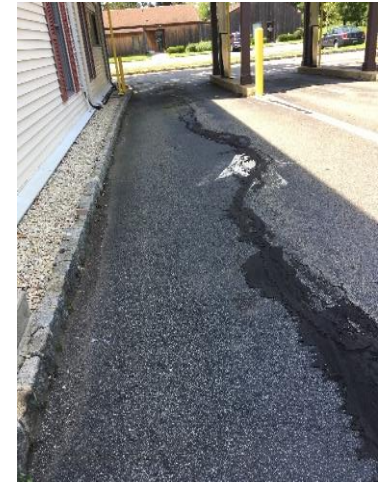
A rain garden installed next to the walkway would capture runoff from the roof, while a bioswale in the front would capture and treat much of the runoff from the parking lot and driveway surfaces.

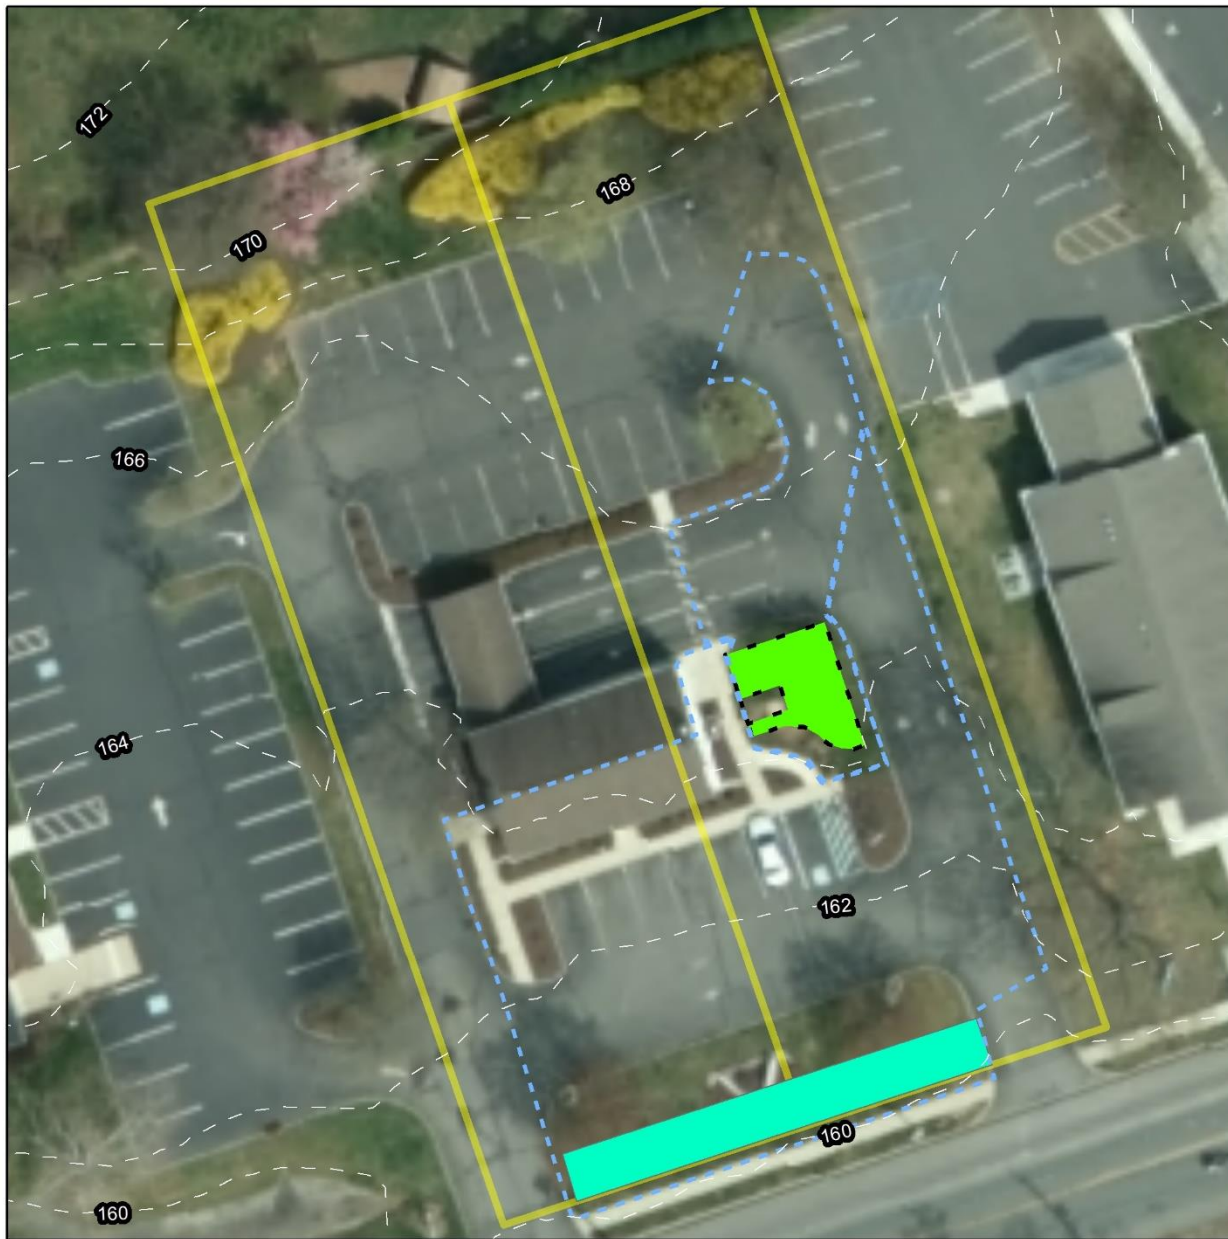
1ST CONSTITUTION BANK 86 EAST BROAD STREET

These measures would remediate 39.5% of the site's impervious cover and could remove 7.43 pounds of pollutants from Beden's Brook annually and restore 271,000 gallons of water to the natural water cycle.

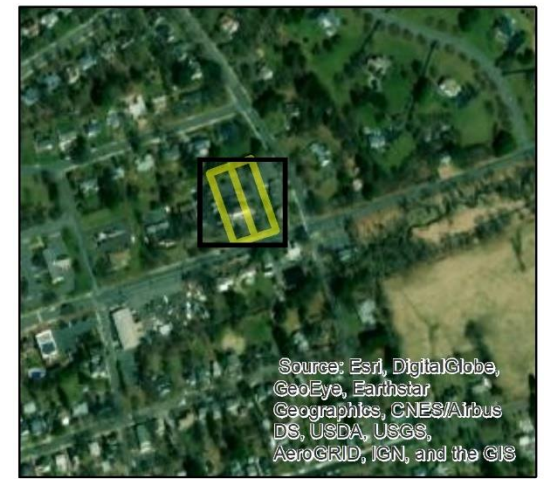
-   Property Line
-   Drainage Area
-   Bioswale
-   Rain Garden

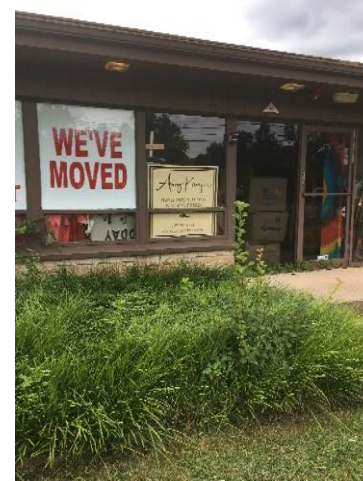
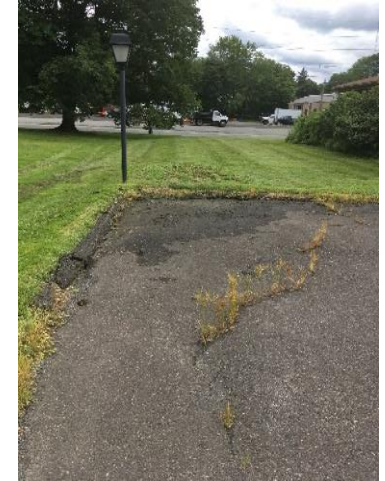
Installing bioswales around the perimeter of the proposed building, rain gardens in the new parking area, and using porous pavement in the new development would remediate 100% of the site's proposed impervious cover.

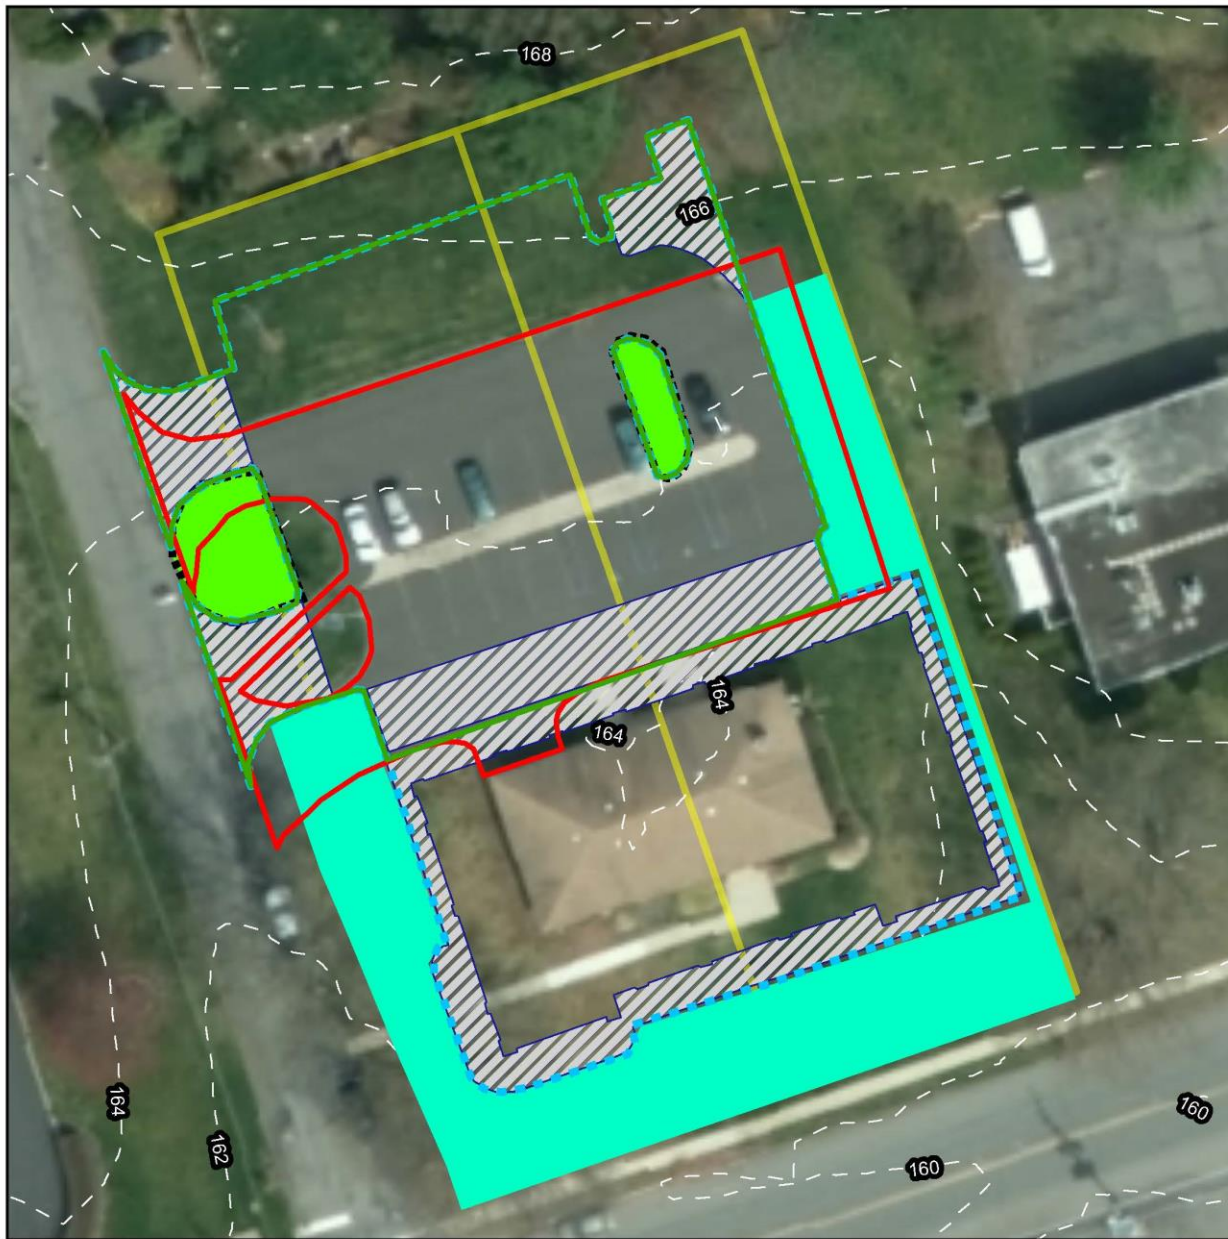
**AMY KARYN INTERIOR DESIGN
64 EAST BROAD STREET**

These measures could remove 67.3 pounds of pollutants from the Beden Brook annually and restore 777,000 gallons of water to the natural water cycle.

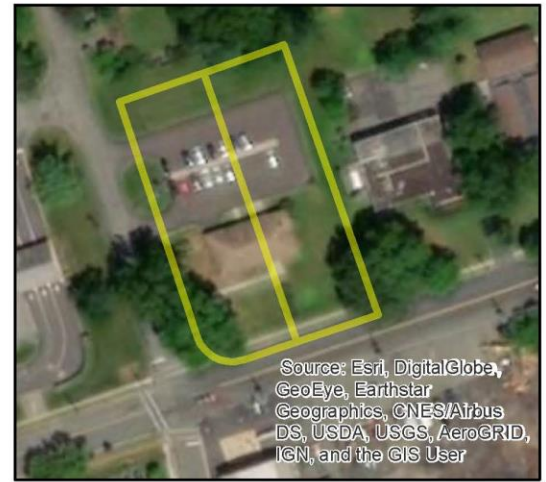
-   Proposed Parking Area
-   Original Parking Area
-   Proposed Drainage Area
-   Bioswale
-   Permeable Pavement
-   Rain Garden
-   Property Line

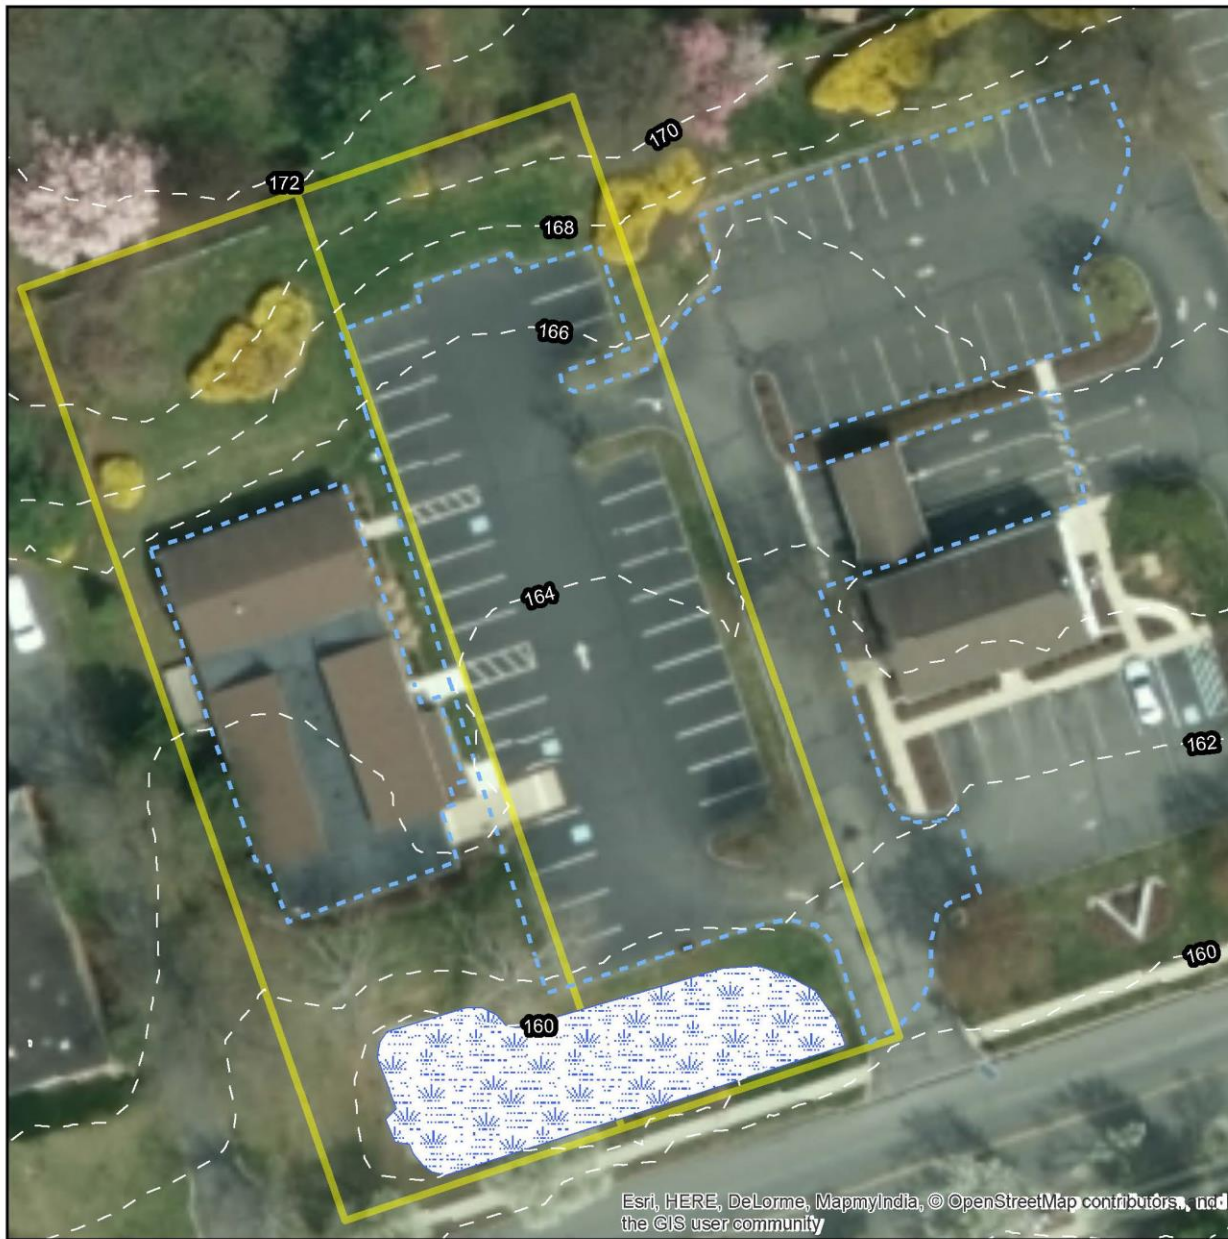
BAXTER
84 EAST BROAD STREET

Naturalizing the stormwater basin would remediate 100% of the site's impervious cover and a significant portion of the neighboring property's. This could remove 15.1 pounds of pollutants from Beden's Brook annually and restore 876,000 gallons of water to the natural water cycle.

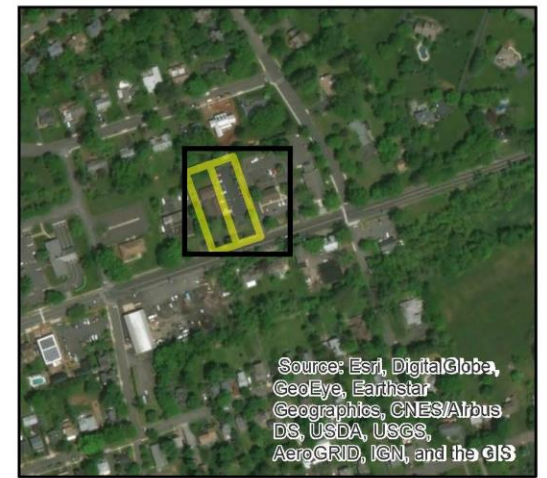
-   Property Line
-   Drainage Area
-   Basin Naturalization

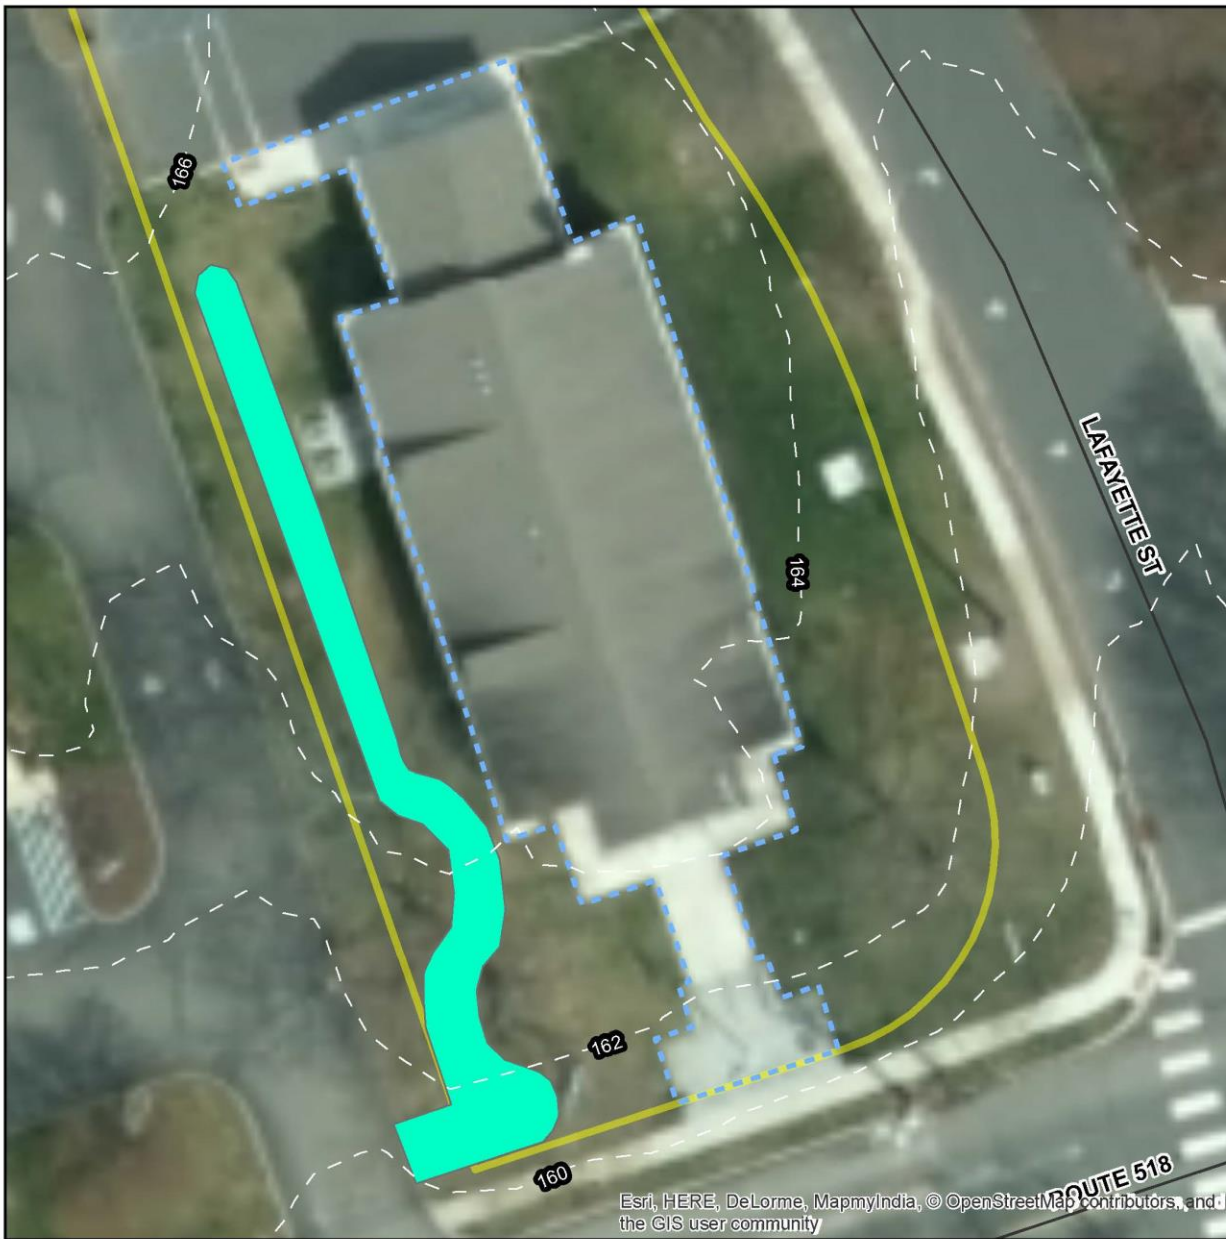
**BORO OF HOPEWELL
COURT CLERK
88 EAST BROAD STREET**

Installing a bioswale along a pre-existing depression on this site would capture runoff from the roof. This would be the beginning of a continuous bioswale on 7 potential restoration sites, running along East Broad Street

This measure would remediate 45.7% of the site's impervious cover and could remove 4.85 pounds of pollutants from Beden's Brook annually and restore 154,000 gallons of water to the natural water cycle.

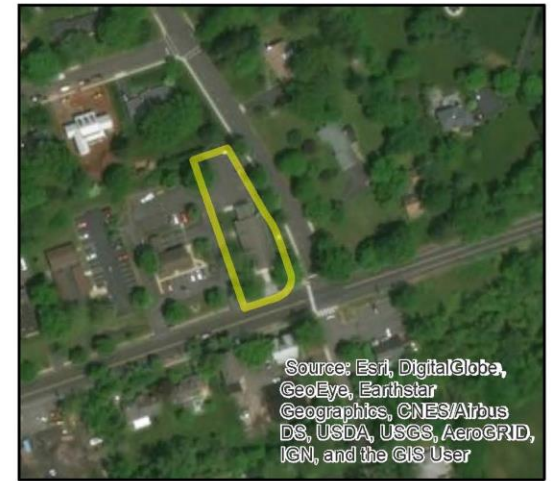
-   Property Line
-   Drainage Area
-   Bioswale

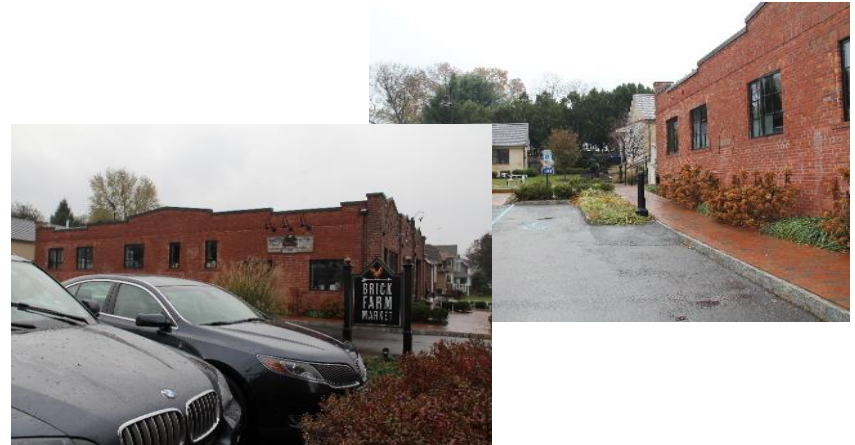
Rain columns along the side of the building would capture runoff from the roof of the main building. The roof runoff from the other two buildings on the property would be redirected to an infiltration trench below the picnic table and a bioswale strip along the back parking spaces. There is a choice between repaving the front parking spaces with porous pavement or installing a bioswale along the sidewalk to capture runoff from the parking lot.

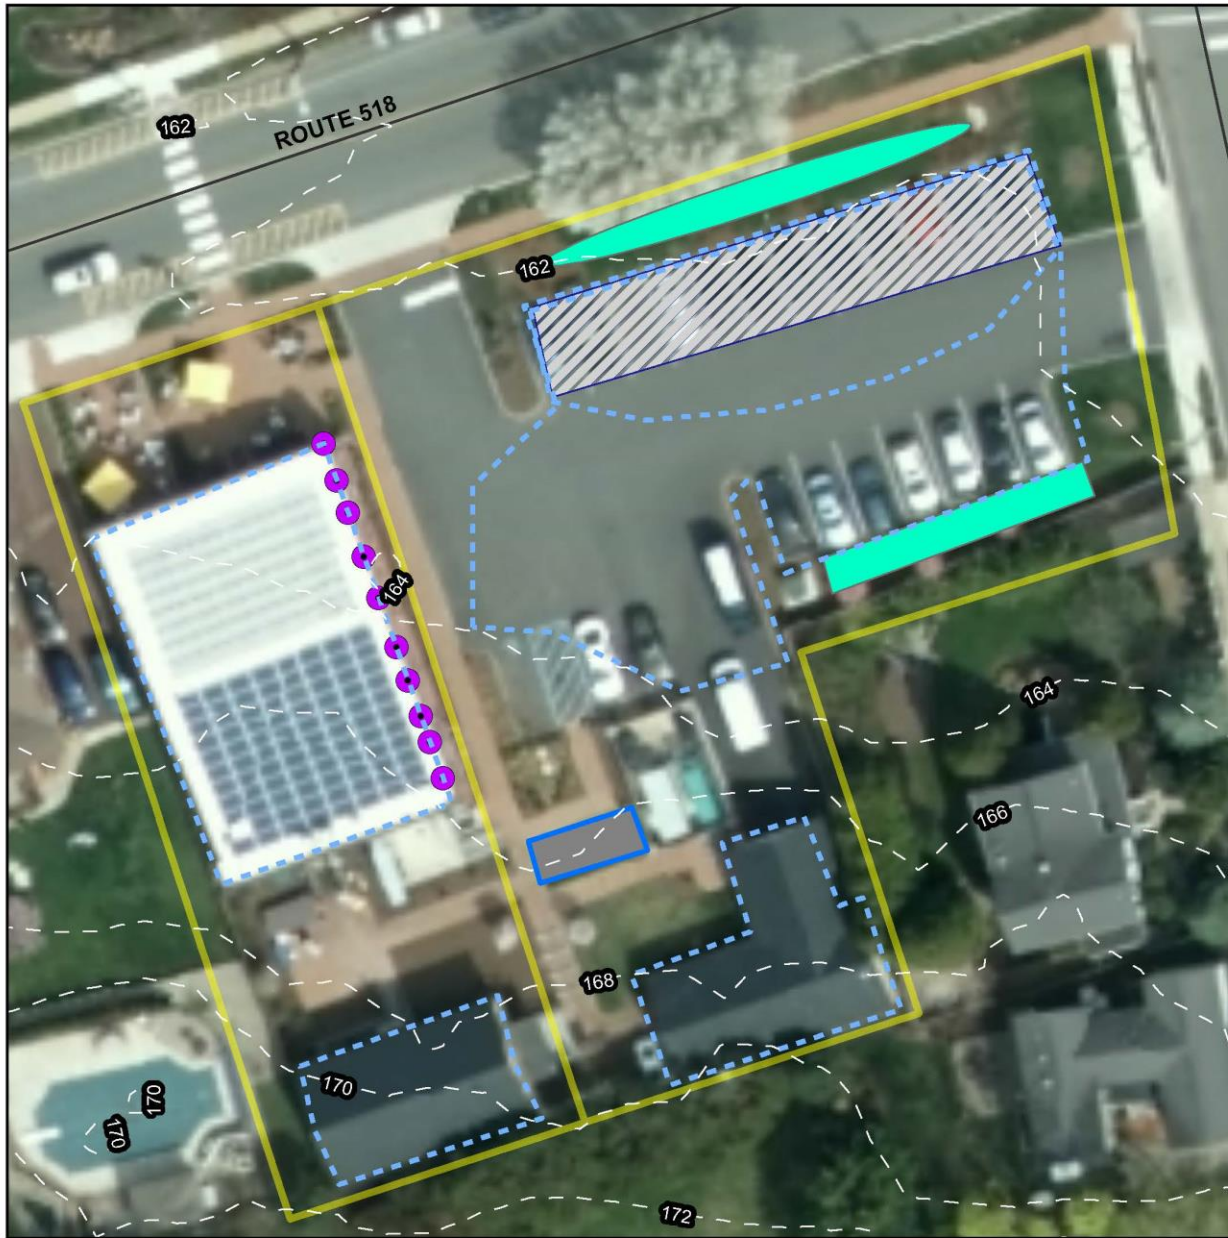
BRICK FARM MARKET 65 EAST BROAD STREET

These measures would remediate 61.6% of the site's impervious cover and could remove 13.5 pounds of pollutants from Beden's Brook annually and restore 516,000 gallons of water to the natural water cycle.

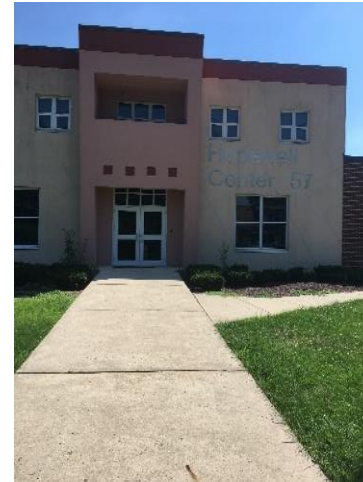
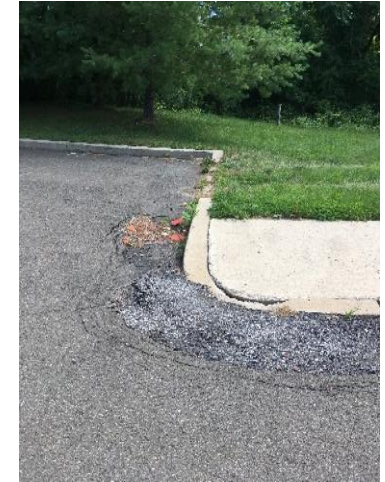
Repaving the parking spots along the road with porous pavement would capture and treat runoff from the main parking lot. A cistern would capture runoff from the roof, and replacing the lawn in the back of the property with a vegetated filter would capture some runoff from the rear parking lot and capture stormwater before it reaches the pavement, alleviating the erosion there.

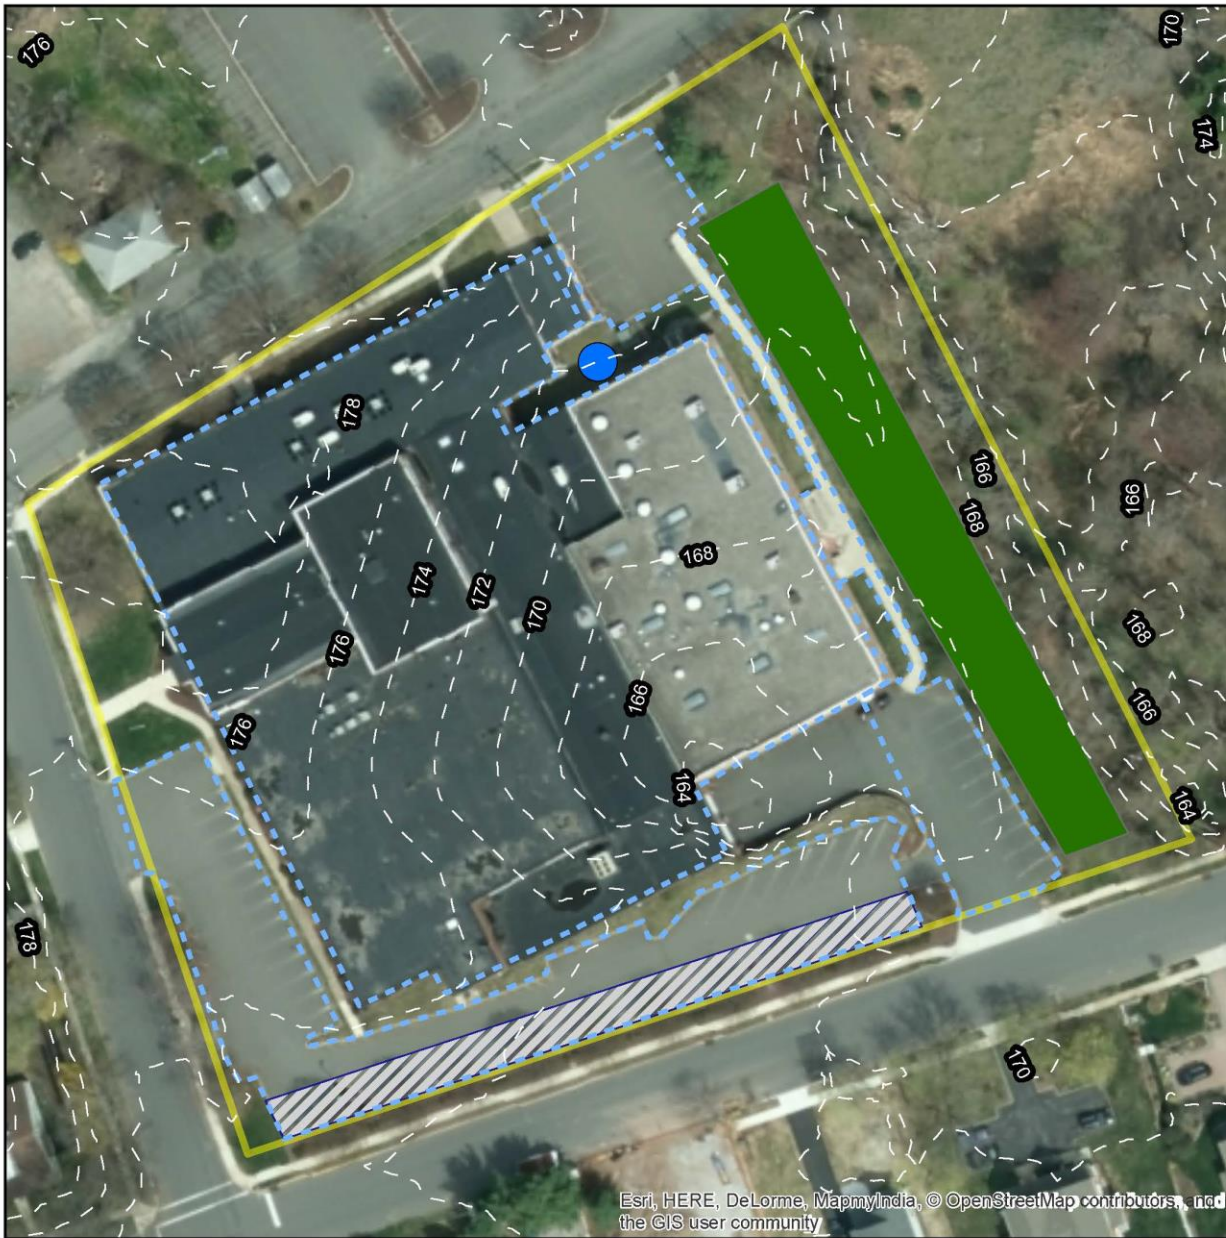
**HOPEWELL CENTER
57 HAMILTON AVENUE**

These measures would remediate 87.4% of the site's impervious cover and could remove 40.5 pounds of pollutants from Beden's Brook annually and restore 2.55 million gallons of water to the natural water cycle.

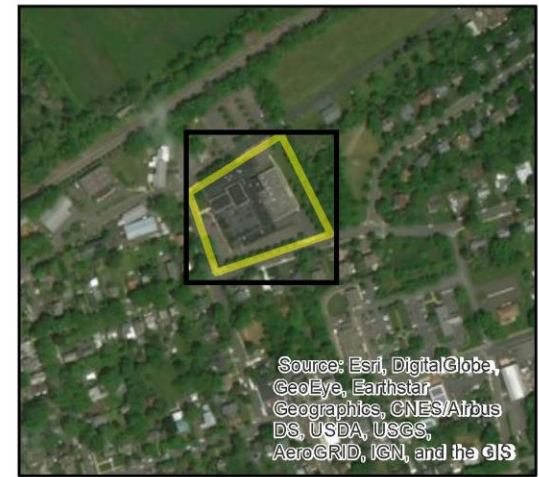
-   Property Line
-   Drainage Area
-   Cistern
-   Porous Pavement
-   Vegetated Swale

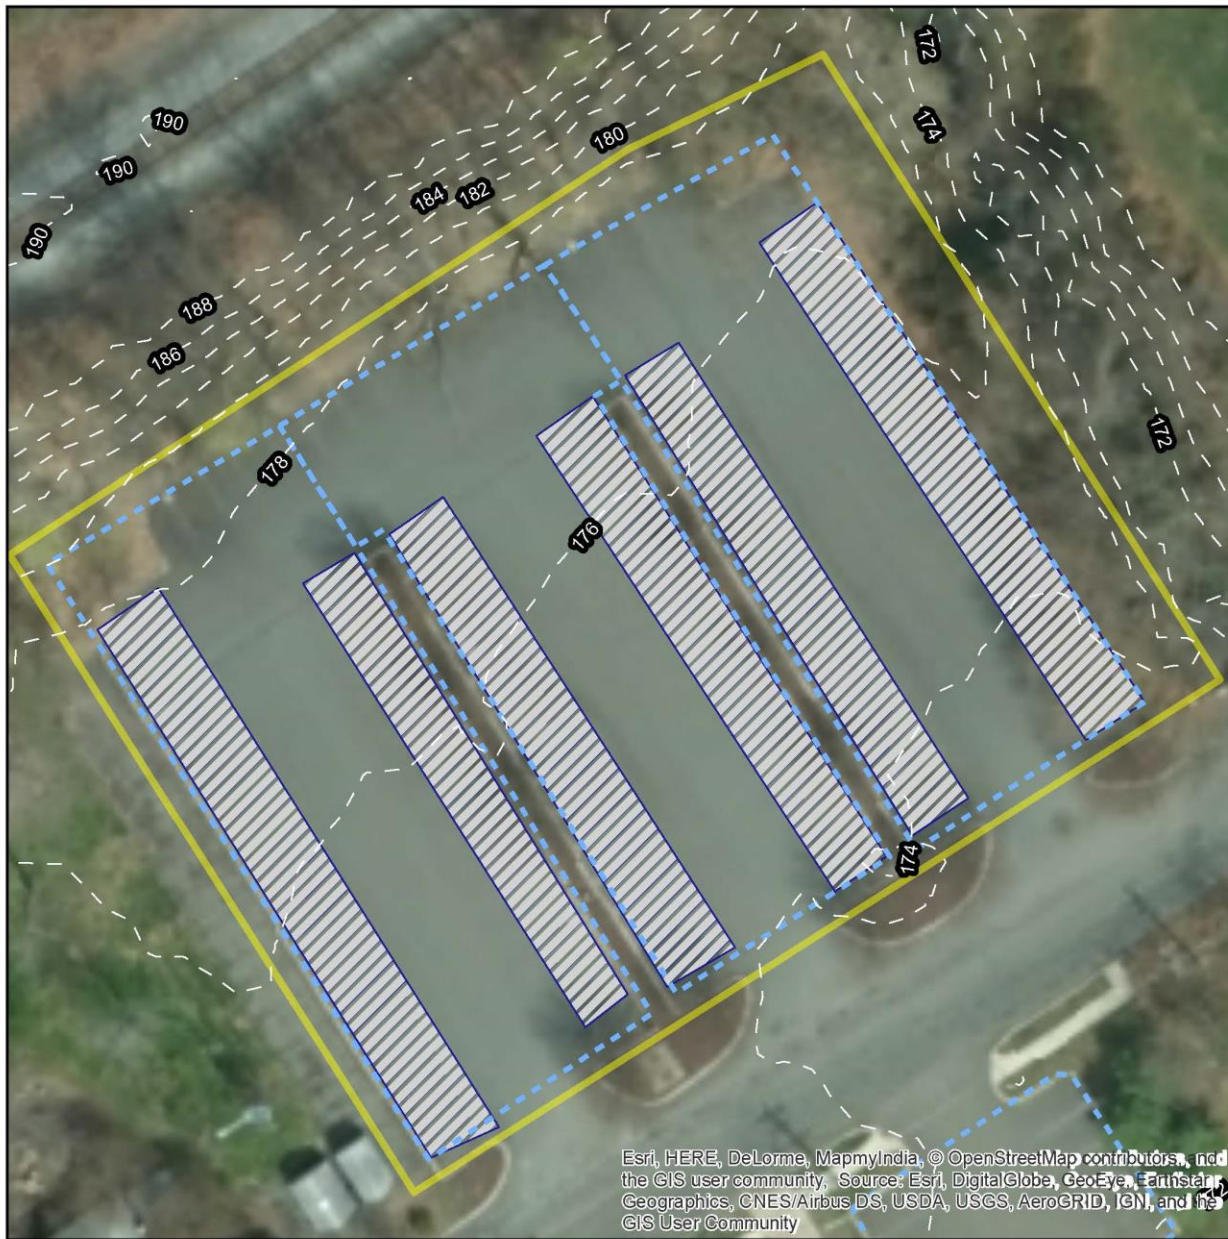
**HOPEWELL CENTER PARKING
62 SOMERSET STREET**

Installing porous pavement in the parking spaces would remediate 90.9% of the site's impervious cover and could remove 29.3 pounds of pollutants from Beden's Brook annually and restore 809,000 gallons of water to the natural water cycle.

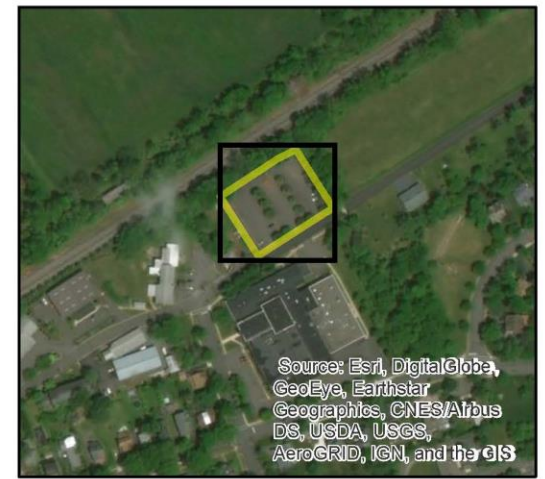
-   Property Line
-   Drainage Area
-   Porous Pavement

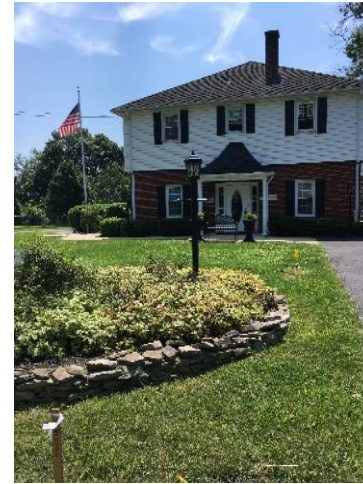
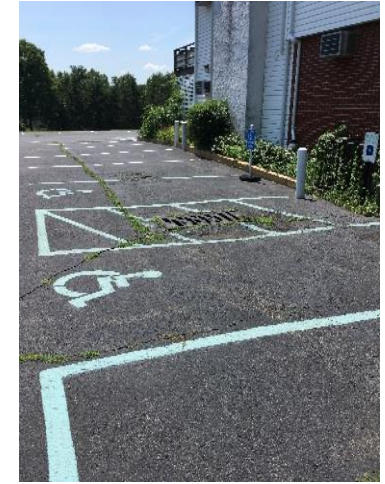
A rain garden in the front would capture runoff from the roof, while a bioswale along the side of the property would capture runoff from the driveway and surrounding compacted lawn. Replacing the lawn in the back with a vegetated filter would capture much of the runoff from the parking lot.

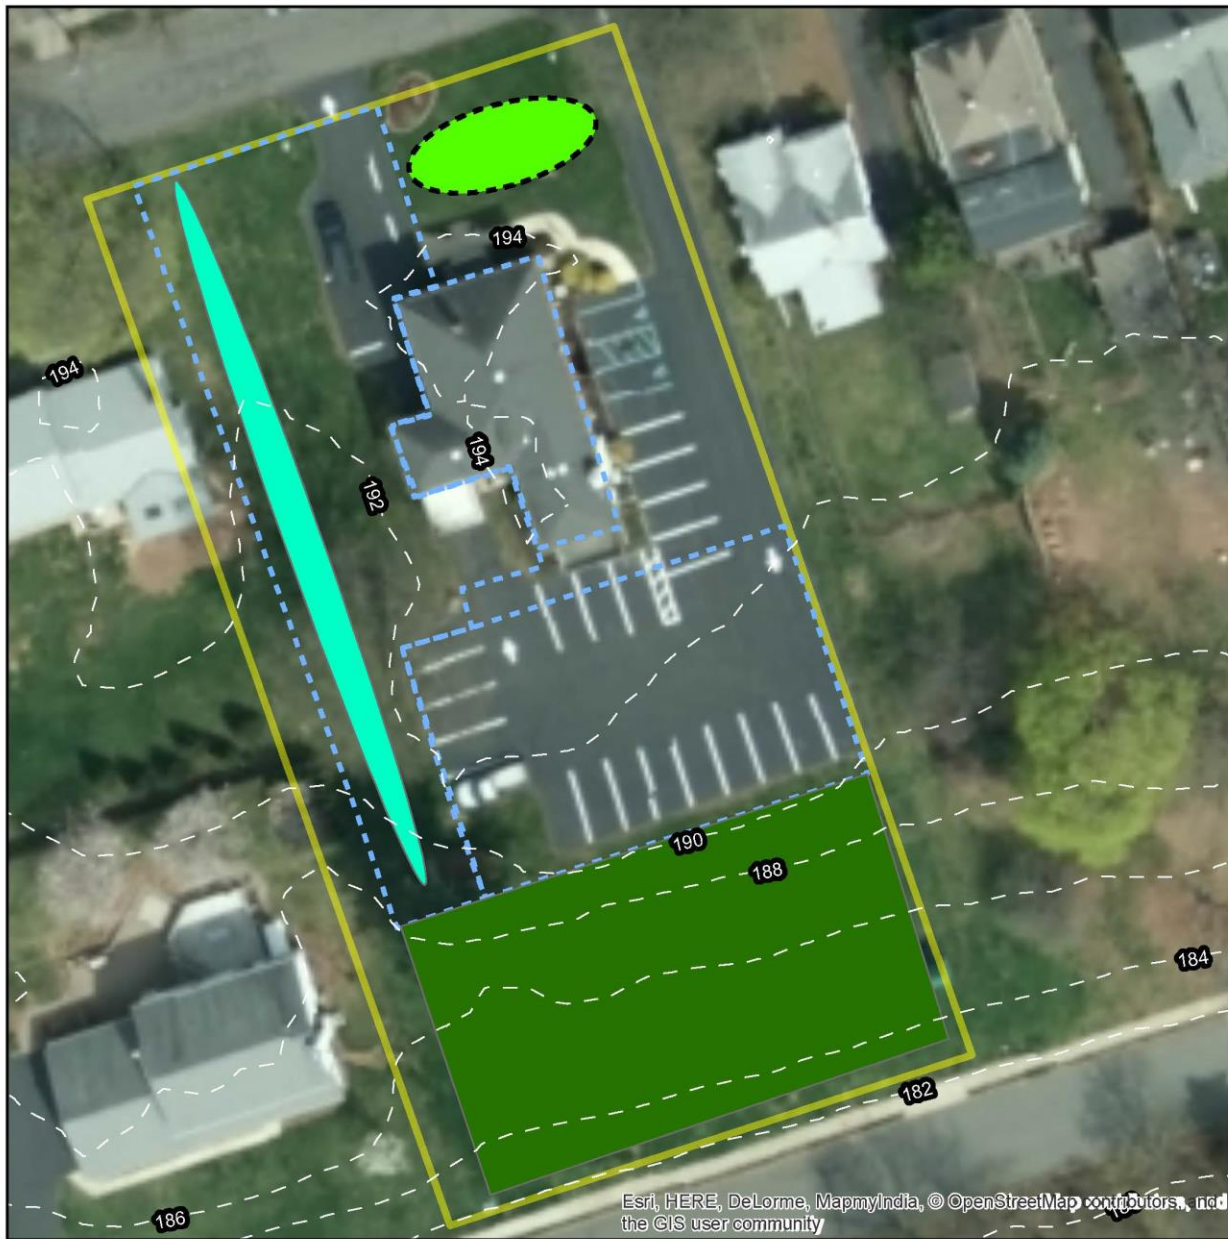
**HOPEWELL MEMORIAL HOME
71 EAST PROSPECT STREET**

These measures would remediate 100% of the site's impervious cover and could remove 27 pounds of pollutants from Beden's Brook annually and restore 490,000 gallons of water to the natural water cycle.

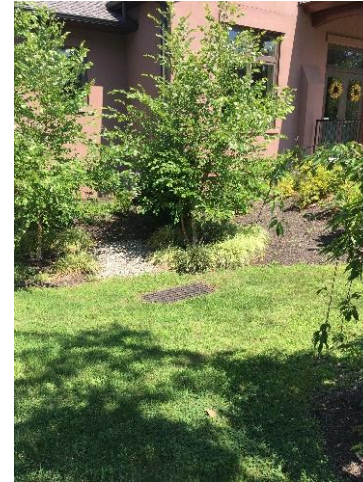
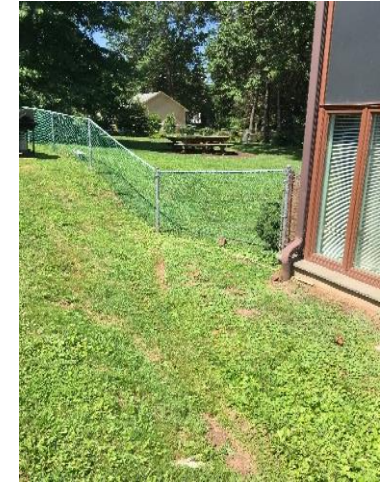
Two rain gardens and a bioswale along the yard would capture runoff from the roof as well as from surrounding compacted grass

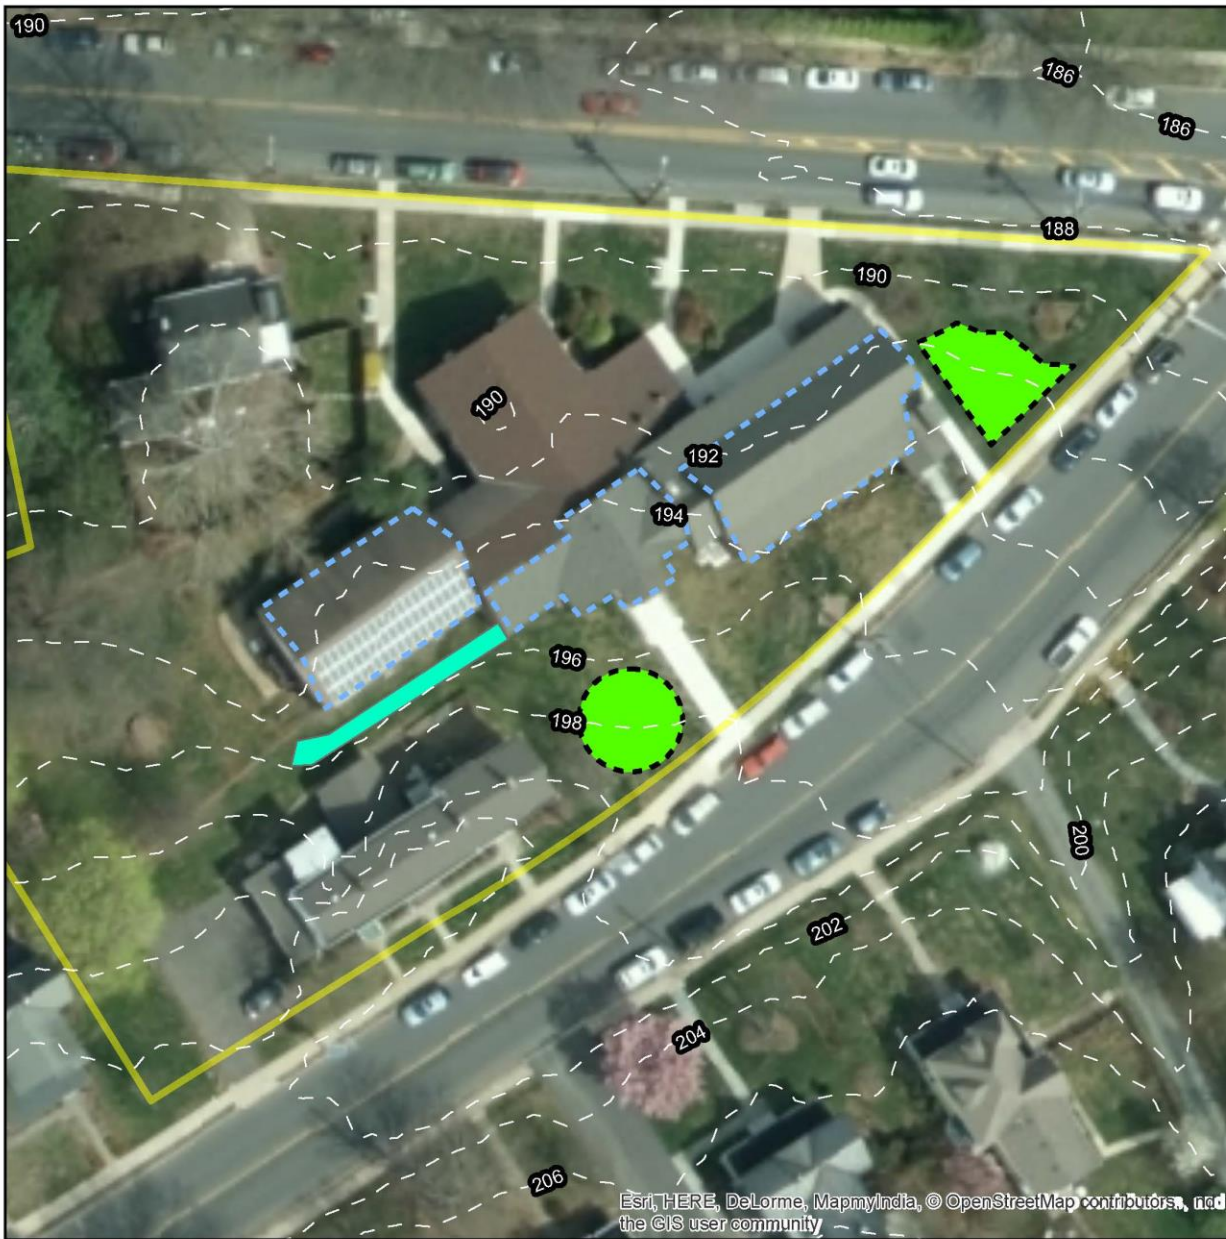
**HOPEWELL PRESBYTERIAN CHURCH
80 WEST BROAD STREET**

These measures would remediate 28.4% of the site's impervious cover and could remove 4.90 pounds of pollutants from Beden's Brook annually and restore 157,000 gallons of water to the natural water cycle.

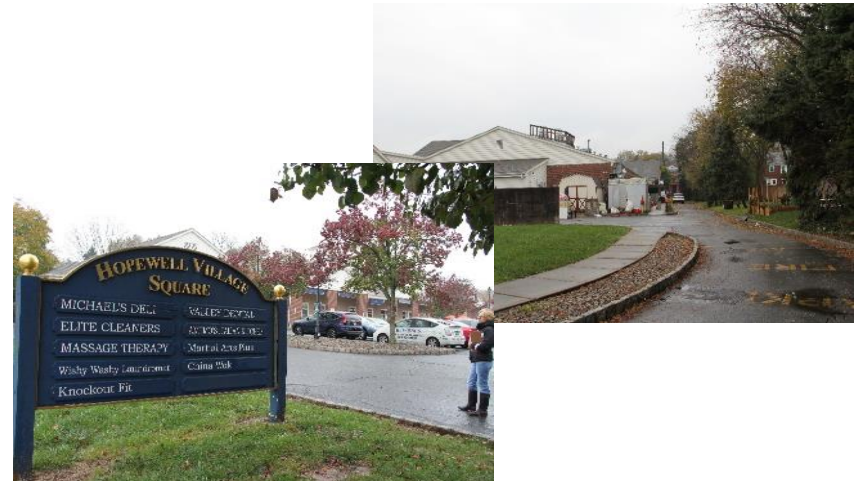
Rain columns and bioswales in the front of the building would capture some of the roof runoff, while strategically placed rain gardens would capture and treat runoff from some parking areas and driveways.

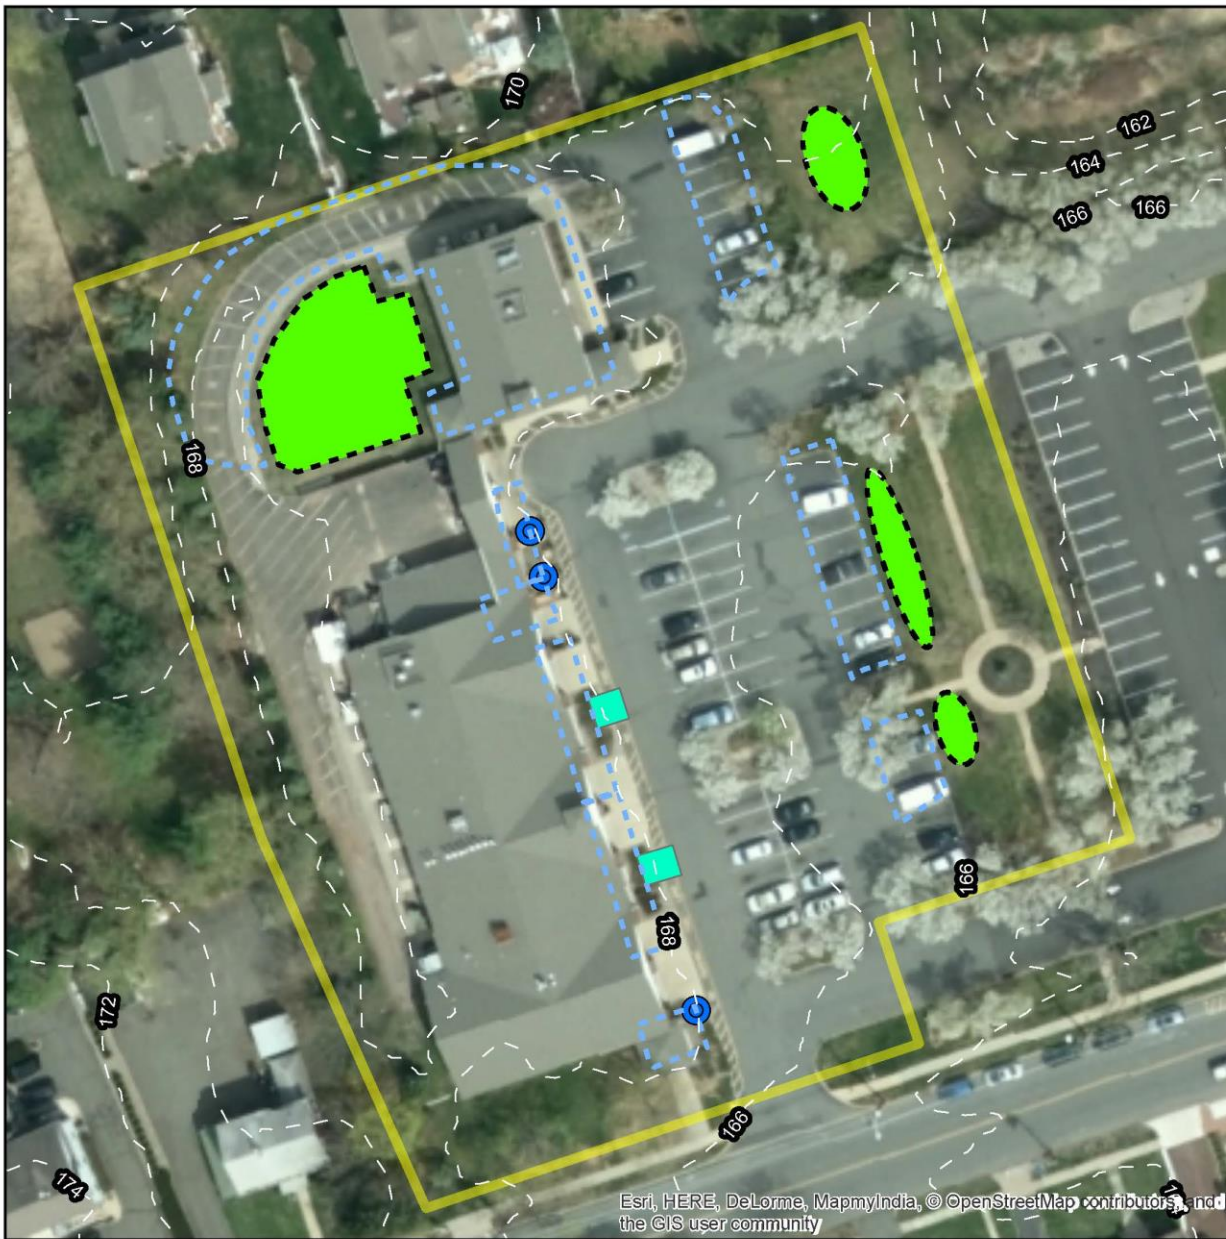
HOPEWELL VILLAGE SQUARE 52 EAST BROAD STREET

These measures would remediate 21.2% of the site's impervious cover and could remove 22.2 pounds of pollutants from Beden's Brook annually and restore 424,000 gallons of water to the natural water cycle.

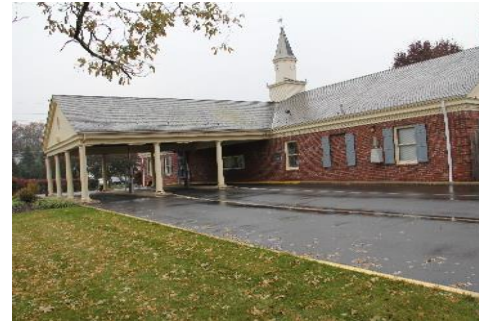
Rain gardens would capture and treat runoff from the roof, while a bioswale along the roadway would treat runoff from the paved surfaces before it reaches storm drains.

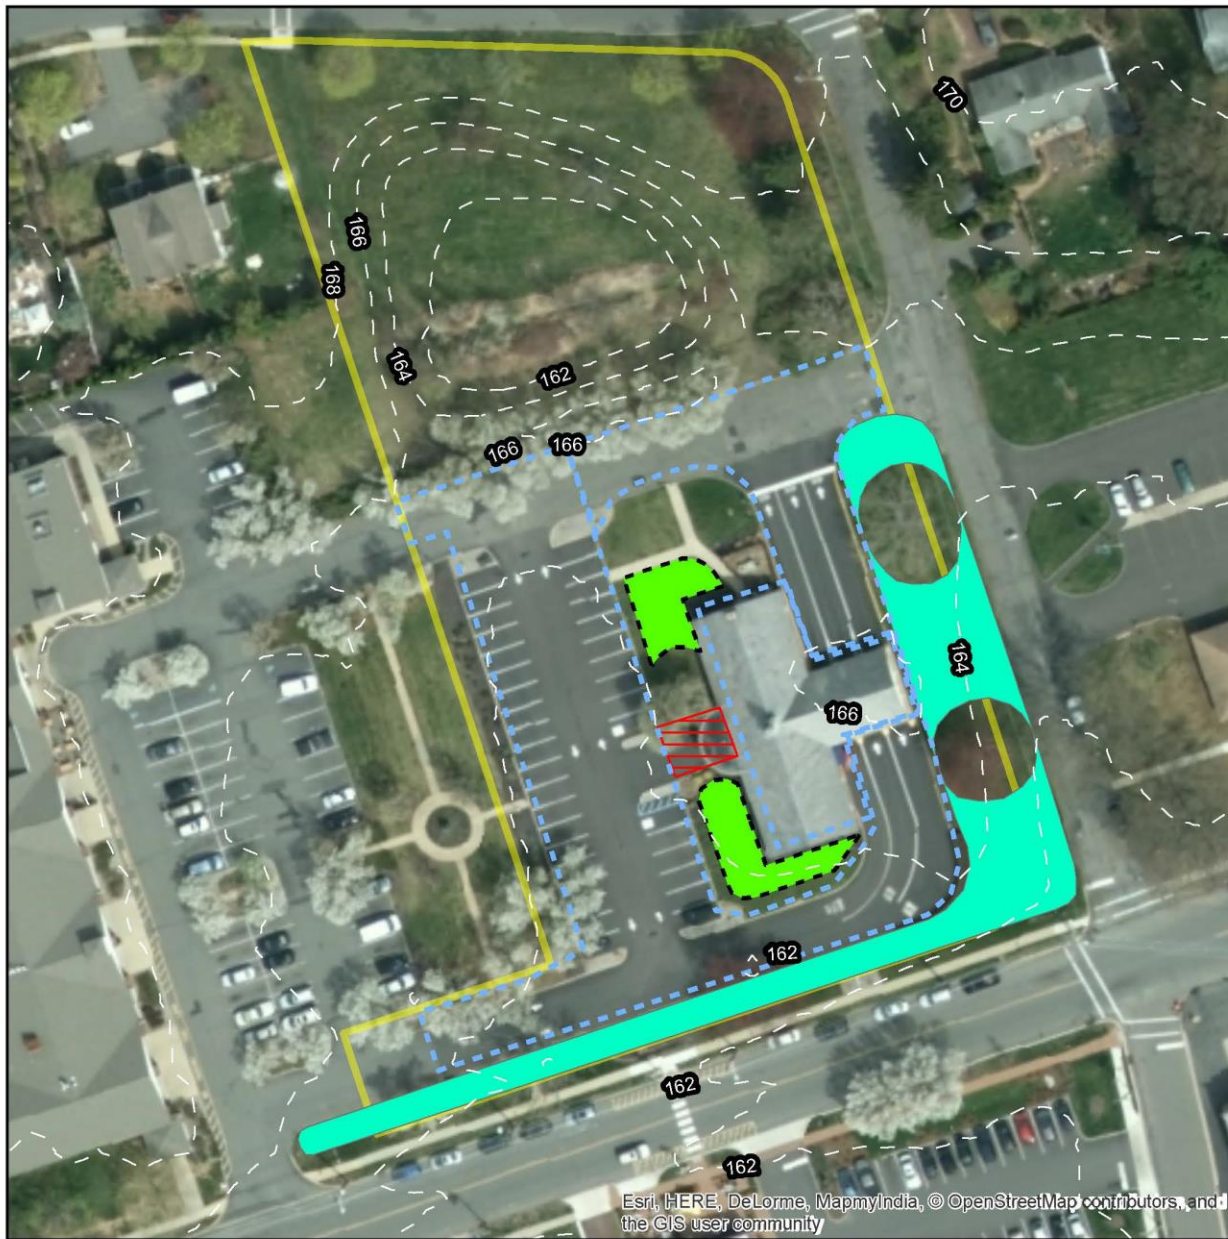
**PNC BANK
62 EAST BROAD STREET**

These measures would remediate 90.4% of the site's impervious cover and could remove 34.5 pounds of pollutants from Beden's Brook annually and restore 1.03 million gallons of water to the natural water cycle.

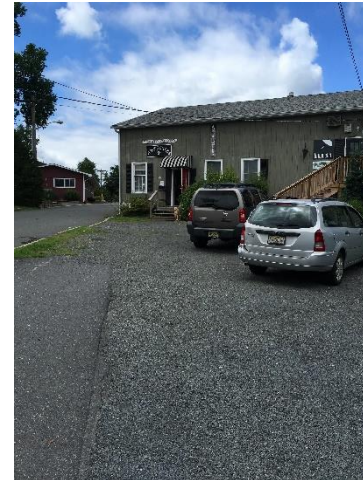
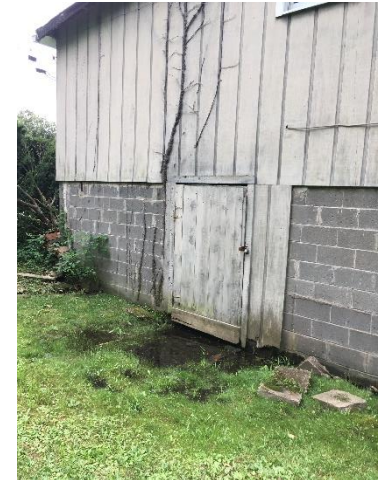
Replacing the compacted gravel parking lot with porous pavement would capture runoff from the roof. Depaving the unused pavement in the rear of the property would remove a significant portion of impervious cover and a rain garden installed in a problem area of the property would treat runoff from the railroad tracks and prevent further erosion.
