1ST CONSTITUTION BANK 86 EAST BROAD STREET

This site currently has 24,700 square feet of impervious cover, creating 723,000 gallons of stormwater runoff and flushing 127 pounds of pollutants into Beden's Brook each year.

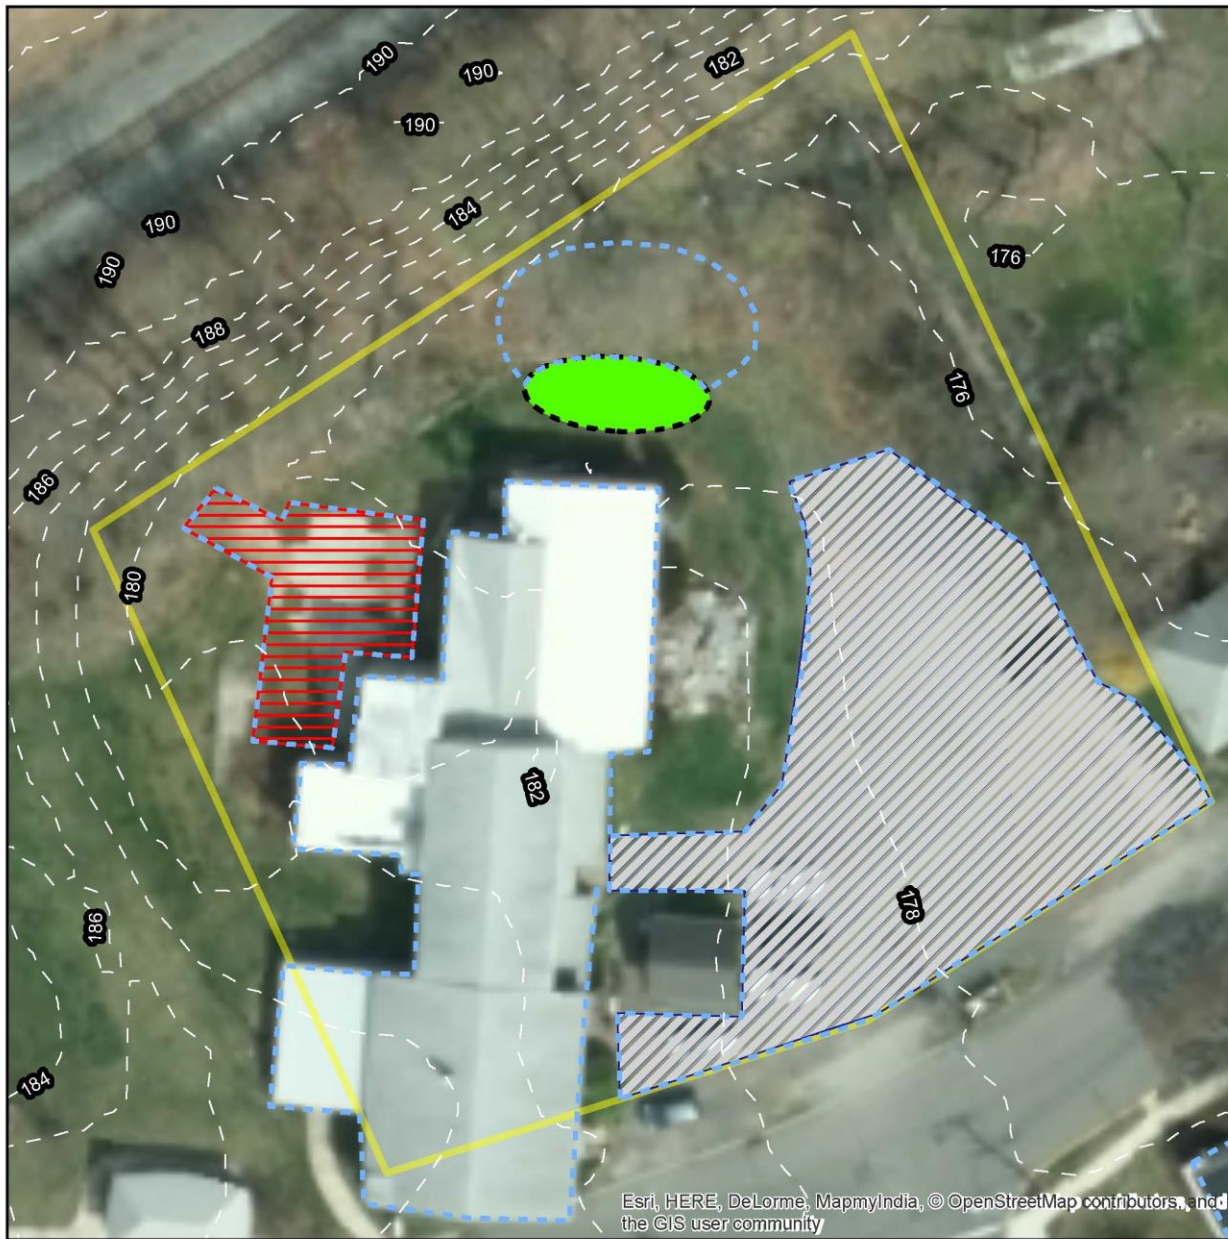
THE TOMATO FACTORY 2 SOMERSET STREET

Replacing the compacted gravel parking lot with porous pavement would capture runoff from the roof. Depaving the unused pavement in the rear of the property would remove a significant portion of impervious cover and a rain garden installed in a problem area of the property would treat runoff from the railroad tracks and prevent further erosion.

These measures would remediate 100% of the site's impervious cover and could remove 18.4 pounds of pollutants from Beden's Brook annually and restore 481,000 gallons of water to the natural water cycle.

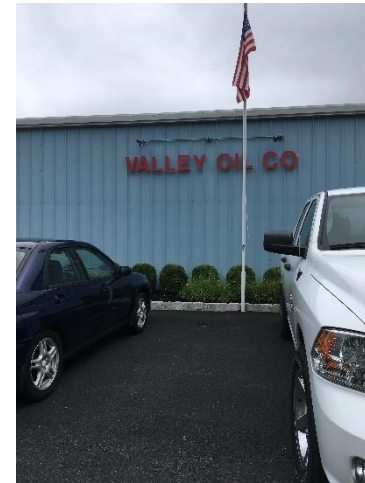
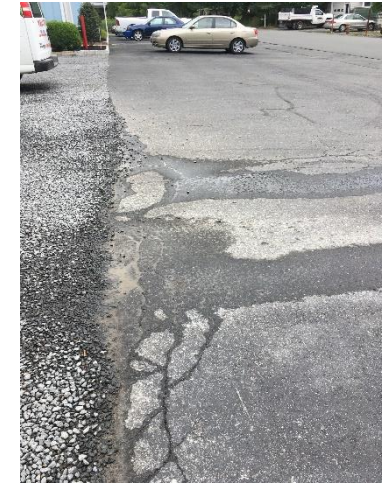
Replacing the compacted gravel parking area with porous pavement would treat runoff from the driveway, while a drywell installed along the side of the building would capture runoff from the roof.

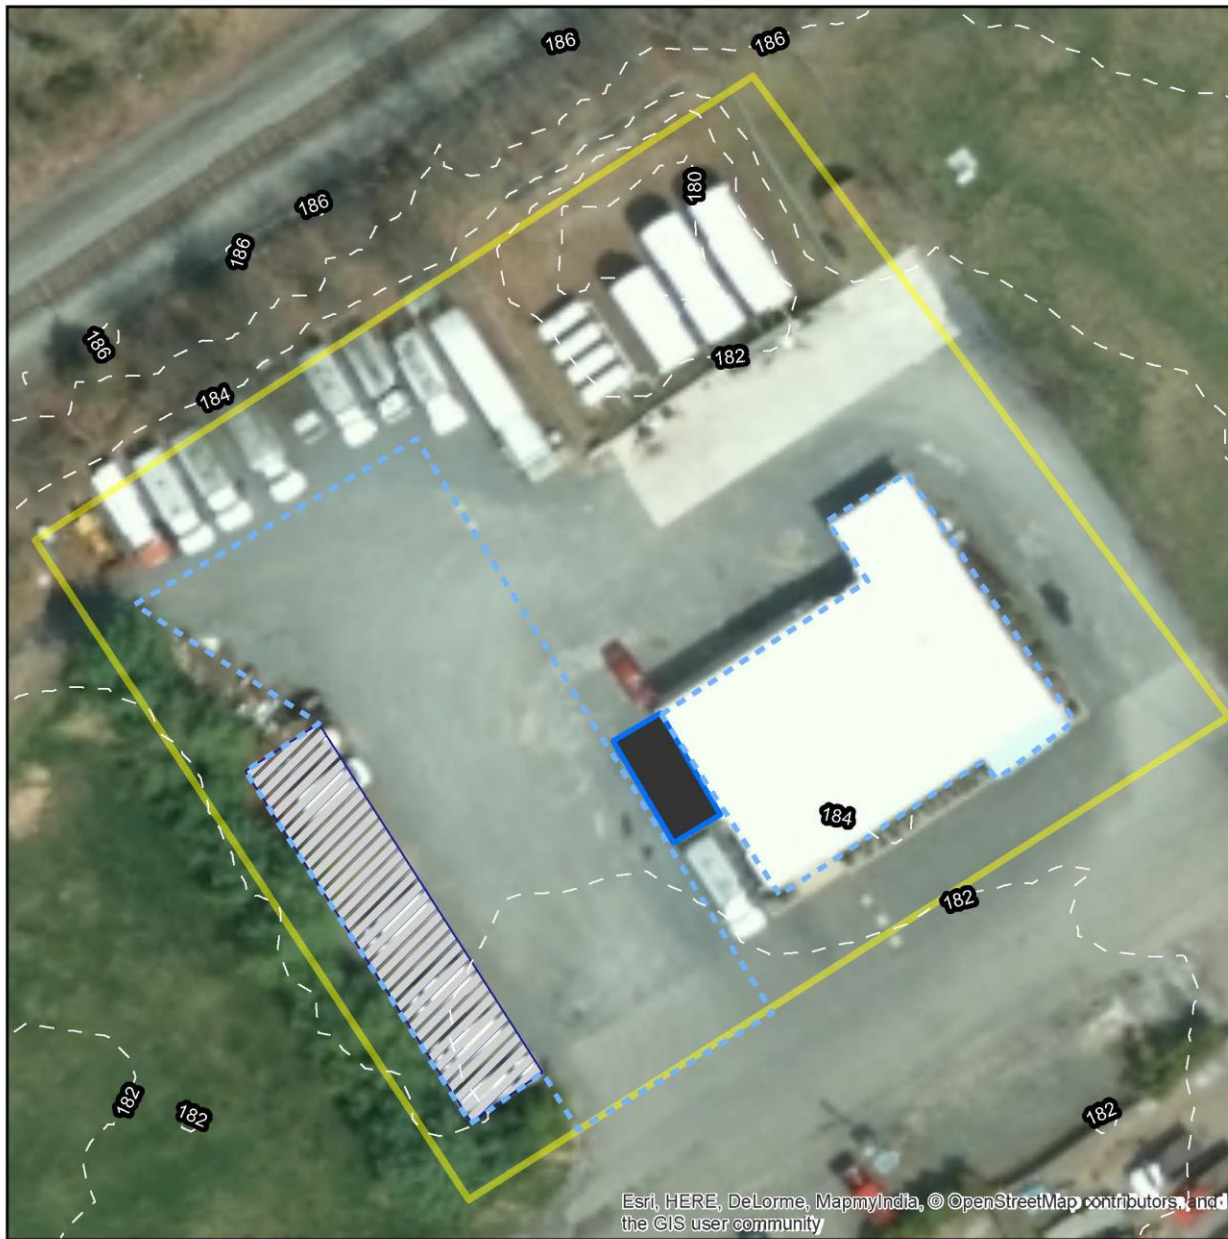
**VALLEY OIL
54 SOMERSET STREET**

This measure would remediate 50.4% of the site's impervious cover and could remove 4.91 pounds of pollutants from Beden's Brook annually and restore 513,000 gallons of water to the natural water cycle.

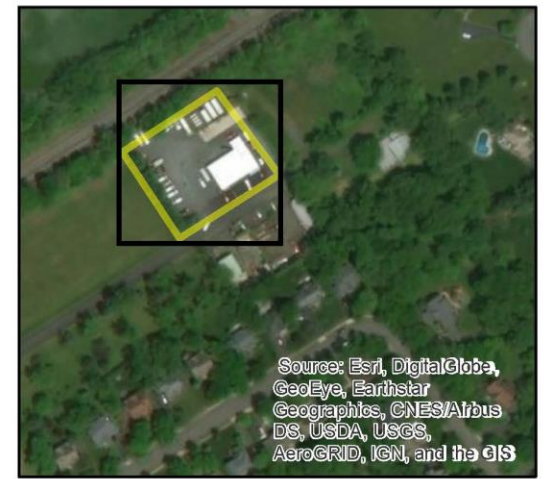
-   Property Line
-   Drainage Area
-   Dry Well
-   Porous Pavement

BMP Type	BMP Area (sq ft)	Reduction Potential (lb/yr)			Maximum Volume Reduction Potential (gal/storm)	Recharge Potential (gal/year)	Estimated Cost
		TP	TN	TSS			
Porous Pavement	2,106	0.03	0.24	4.64	24,196	326,965	\$25,268.38
Dry Well	379	0.00	0.00	0.00	13,770	186,081	\$3,787.30
Total	2,484	0.03	0.24	4.64	37,967	513,046	\$29,055.68

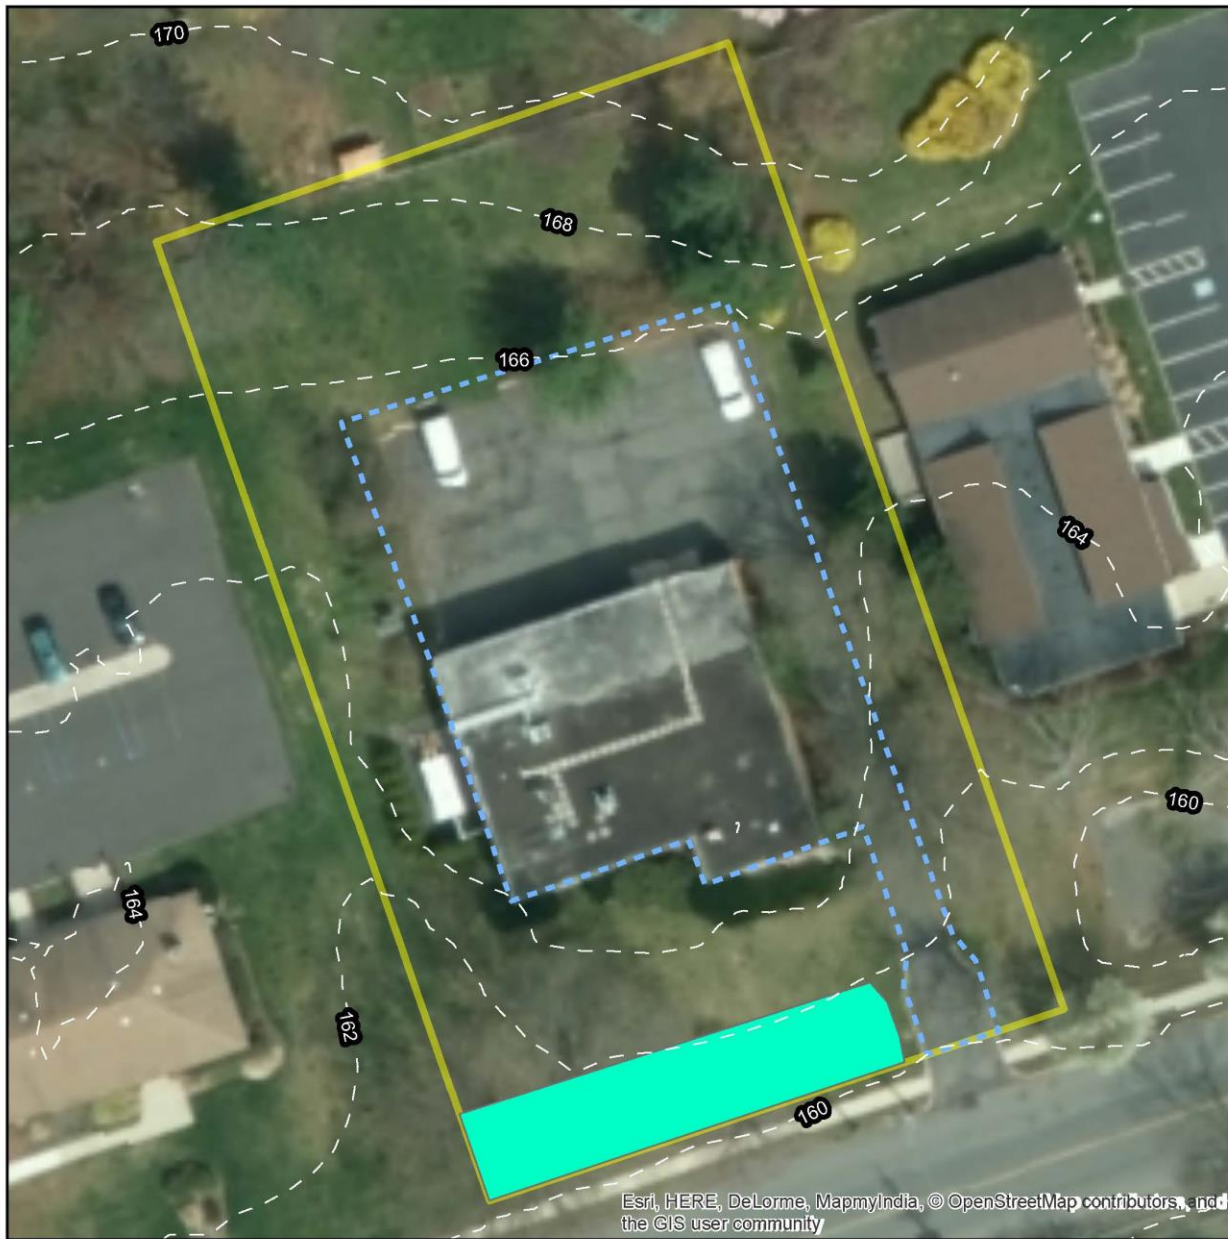
VERIZON WIRELESS 68 EAST BROAD STREET

A bioswale, part of a contiguous bioswale along East Broad Street, would remediate 100% of the site's impervious cover and could remove 10.2 pounds of pollutants from Beden's Brook annually and restore 380,000 gallons of water to the natural water cycle.
