USEPA Targeted Watershed Grant Project for the Millstone Watershed Fact Sheet

Pike Run Habitat Enhancement and Restoration Project Montgomery Township, Somerset County

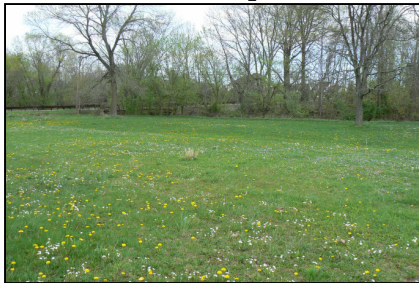
Wetland meadow pre-restoration

Phase 1 occurred in May 2007 when volunteers planted nearly 2800 native riparian and wetland species of shrubs and herbaceous plugs in a 1.27-acre wetland meadow adjacent to Pike Run. The area had been

maintained by mowing to the stream edge, but was rarely used recreationally because of its wet nature. The TWP Parks Department installed a 7-foot deer fence around the tilled area to protect plants, giving them a greater chance of survival.

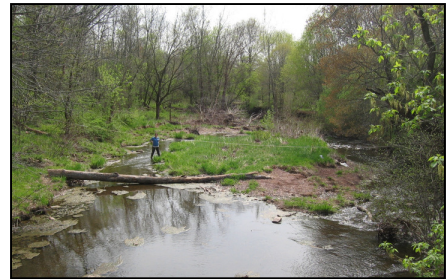
Pike Run at normal flow

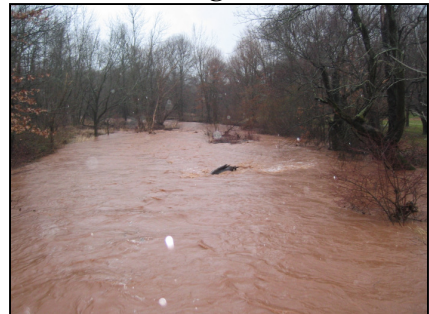
Pike Run at high flow

The site is located in the very actively used Montgomery Park, owned and maintained by Montgomery TWP. This reach of Pike Run has degraded due to ever-increasing upstream development, resulting in the redirection of enormous amounts of stormwater runoff directly to the stream. As a result, there are very flashy flows during and after rainstorms, which have eroded the stream bottom down to bedrock in much of the reach, incised the stream channel approximately 3-5 feet below the top of bank, widened and straightened the stream, eliminated the typical riffle-pool habitats, and disconnected the stream from its floodplain.

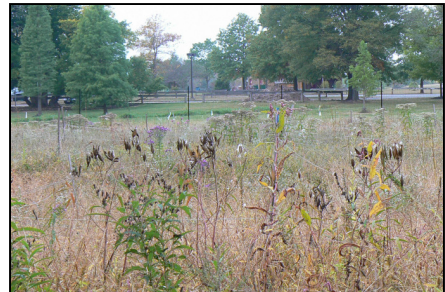
Restored wetland meadow, Oct. 2007

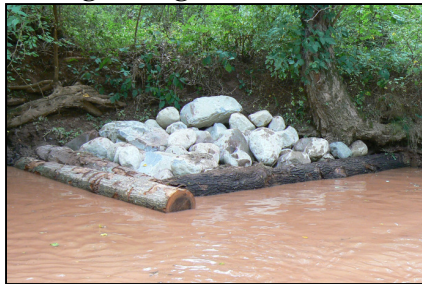
Single-wing deflector

Phase 2, instream restoration, occurred in August 2007 and involved the installation of a series of instream structures (single-wing deflectors paired with cover logs) downstream of the wetland restoration area. Single-wing deflectors are constructed of natural logs and boulders. Placement of the deflectors on alternating banks will, over time, re-direct stream flow to create a meandering stream flow pattern within the existing banks. Since regrading the banks using more traditional streambank stabilization methods would result in the loss of both significant trees and a large amount of municipal park acreage, the project had to focus within the existing banks. Deposition occurring naturally upstream of the deflector will result in the formation of riffles, and scouring downstream of the structure will form pools to create instream habitat for macroinvertebrates and fish. Additionally, 126 native trees and shrubs planted by the deflectors and cover logs will protect the banks from potential erosion and grow to become good instream fish habitat along the banks.

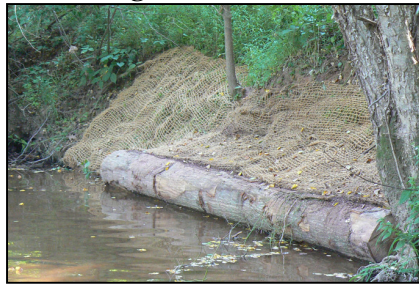
Cover log

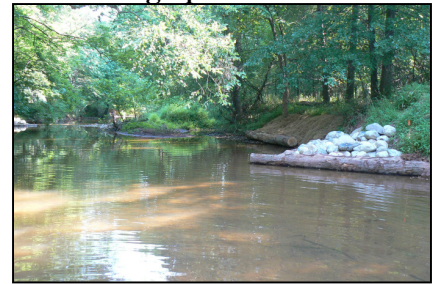
Single-wing deflector with cover log upstream of it

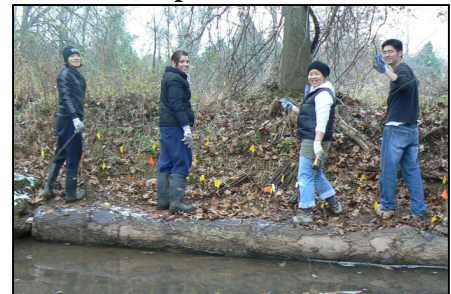
Volunteers plant live stakes

Phase 3, which took place in December 2007, involved planting 1000 live stakes along Pike Run's streambanks near the single-wing deflectors, cover logs, and between the pedestrian bridge and the structures using volunteers (Figures 8 and 9). These live stakes must be planted during the dormant season. The native dogwoods, willows, and viburnums will grow into trees and shrubs that will further stabilize the banks and provide good fish habitat. The live stakes used in a 1997 Pike Run streambank stabilization project at Montgomery Park are thriving, indicating that this method works very well here.

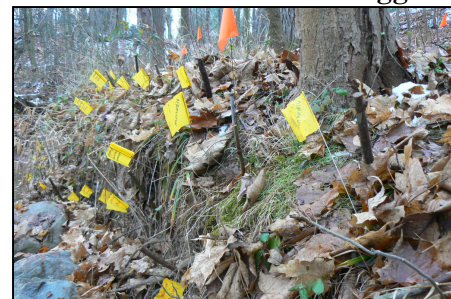
Live stakes installed and flagged
